Annual Inspection

Wreningham Parish Council

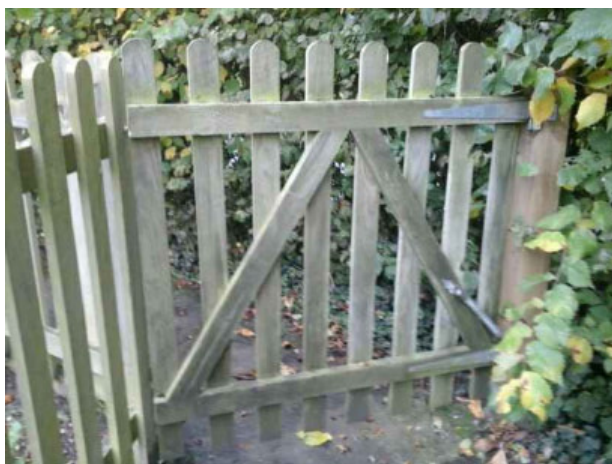
Item: Ancillary Items - Gate
Manufacturer: Unknown
Surface Type: N/A
Equipment Compliance: N/A
Surface Area Compliance: N/A
Ref/Part Number:
Total Findings: 1

The spring is broken - Replace the spring

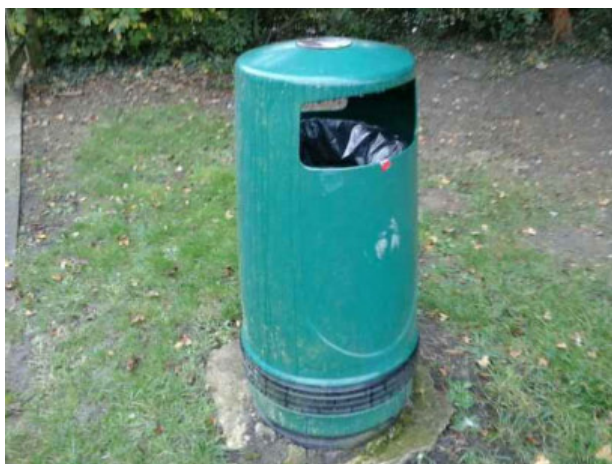
Item: Ancillary Items - Litter Bin
Manufacturer: Owner/Operator
Surface Type: N/A
Equipment Compliance: N/A
Surface Area Compliance: N/A
Ref/Part Number:
Total Findings: 1

The item is loose in its foundations - Reinstall item to secure

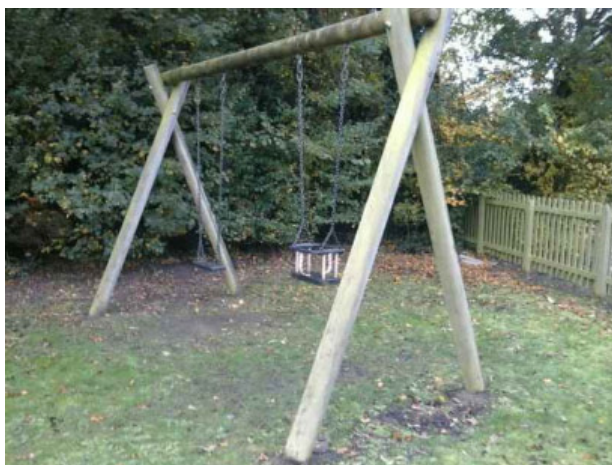
Item: Swings - 1 Bay Mixed Seat, 1 Cradle, 1 Flat
Manufacturer: Adventure Playgrounds
Surface Type: Grass Matrix Tiles
Equipment Compliance: Yes
Surface Area Compliance: Yes
Ref/Part Number:
Total Findings: 5
Life Expectancy: 5 -10 Years

The use of mixed seats in one bay is not generally recommended but in some circumstances can be justified using risk assessment considering the type and number of users anticipated in the area - Ensure a suitable and sufficient risk assessment has been undertaken

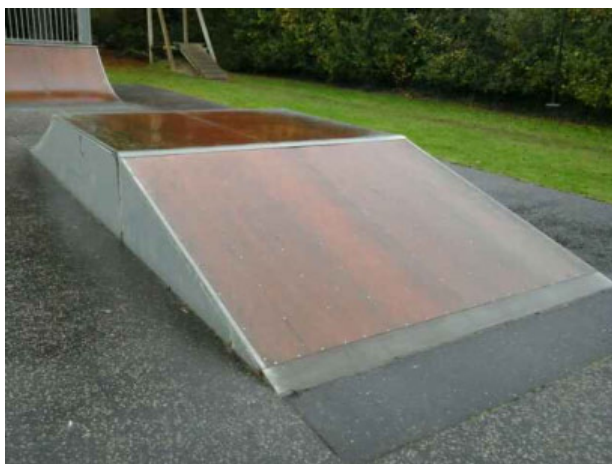
Item: Wheeled Sports - Fun Box
Manufacturer: Not Identified
Surface Type: Tarmac
Equipment Compliance: No
Surface Area Compliance: Yes
Ref/Part Number:
Total Findings: 5
Life Expectancy: 5 -10 Years

There is algae or moss growth on the surface resulting in slippery conditions - Clean and treat appropriately

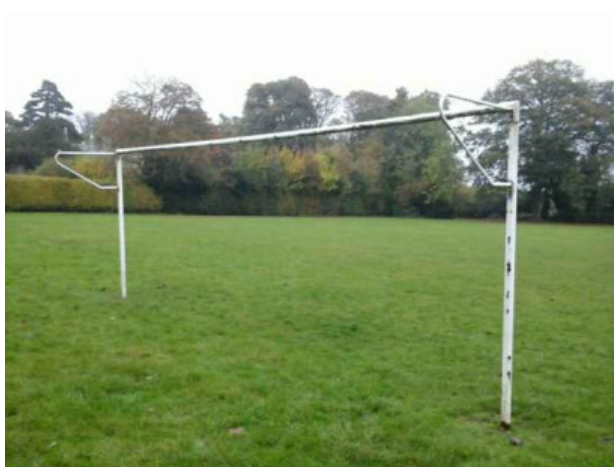
Item: Multi Use Games Area - Football Goal
Manufacturer: Not Identified
Surface Type: Grass
Equipment Compliance: N/A
Surface Area Compliance: N/A
Ref/Part Number:
Total Findings: 4
Life Expectancy: 3 - 5 Years

The paintwork on this item has been damaged or worn exposing the metal underneath which is rusting - Treat any rusting components and repaint

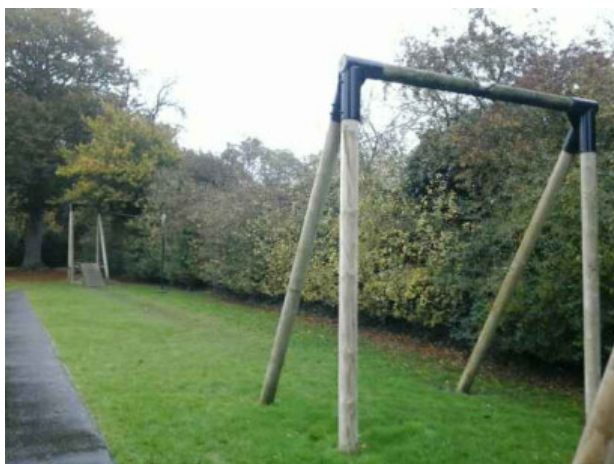
Item: Other - Cable Runway
Manufacturer: Norfolk Games and Frames
Surface Type: Grass Matrix Tiles
Equipment Compliance: No
Surface Area Compliance: Yes
Ref/Part Number:
Total Findings: 5
Life Expectancy: 5 - 10 Years

We recommend that the main cable is thoroughly inspected at least once every 2 years this; will involve either removing the cable or gaining access by ladders and/or steps to inspect for damage or internal rusting, this will help to ensure the continued safe use of the equipment - Inspect cable every 24 months

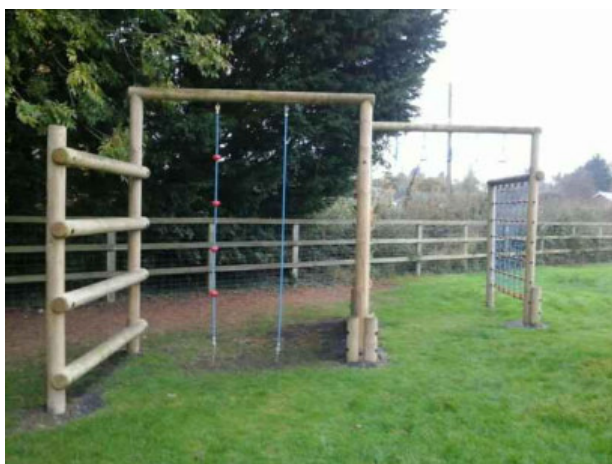
Item: Activity Equipment - Climbing Frame
Manufacturer: Norfolk Games and Frames
Surface Type: Grass Matrix Tiles
Equipment Compliance: Yes
Surface Area Compliance: Yes
Ref/Part Number:
Total Findings: 2
Life Expectancy: 5 -10 Years

There is/are bolt cap covers missing or damaged on the item - Replace missing or damaged bolt cap covers

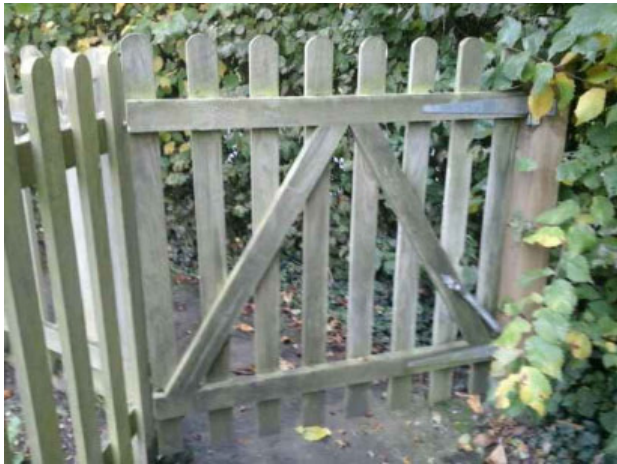
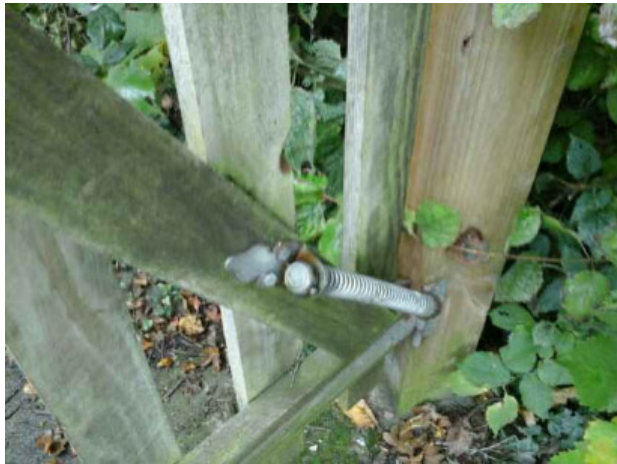
6 - Low Risk (Finding 1)			
Item:	Ancillary Items - Gate	Risk Level:	L - Low Risk
Manufacturer:	Unknown	Surface:	N/A

Finding:	The spring is broken		Action: Replace the spring

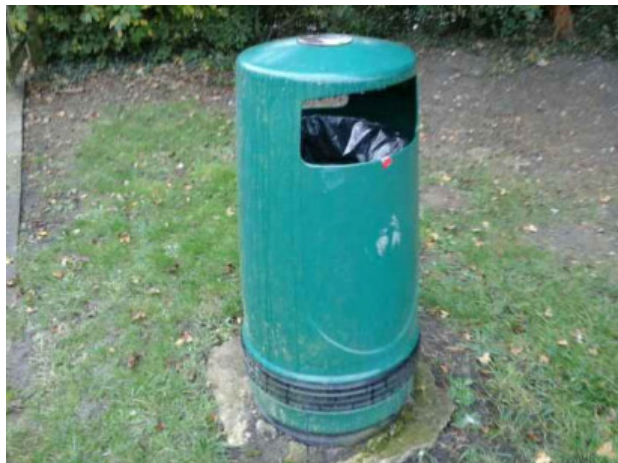
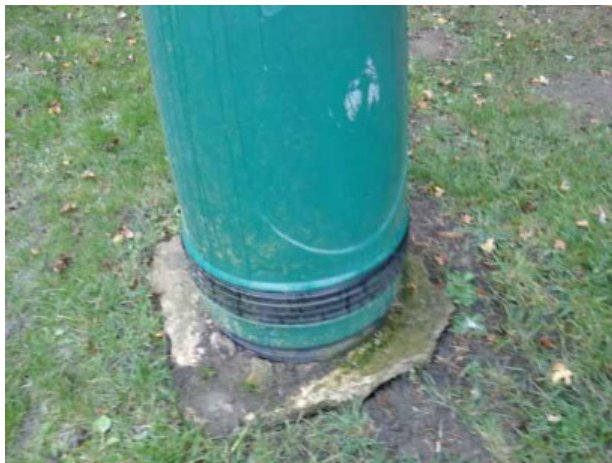
Item: Ancillary Items - Litter Bin
Manufacturer: Owner/Operator

Finding: The item is loose in its foundations

Action: Reinstall item to secure

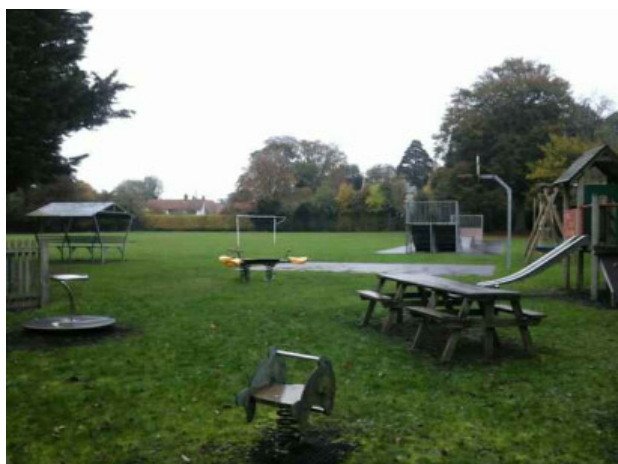
Item: Ancillary Items - Site General
Manufacturer: Owner/Operator

Finding: There are a number of molehills within the area and these may present unforeseen hazards for users

Action: Remove moles by appropriate means, reinstate surfaces to level and maintain the area

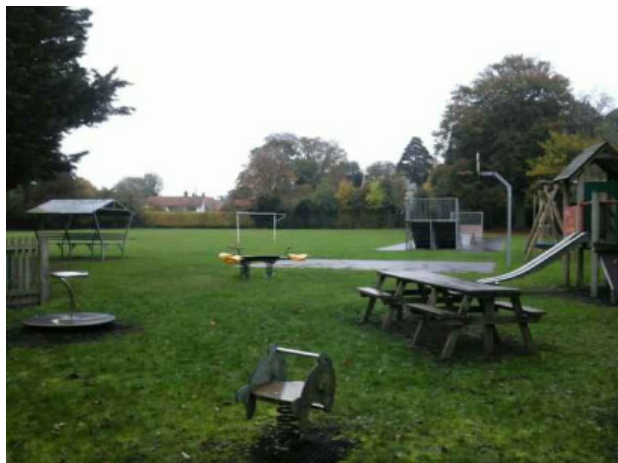
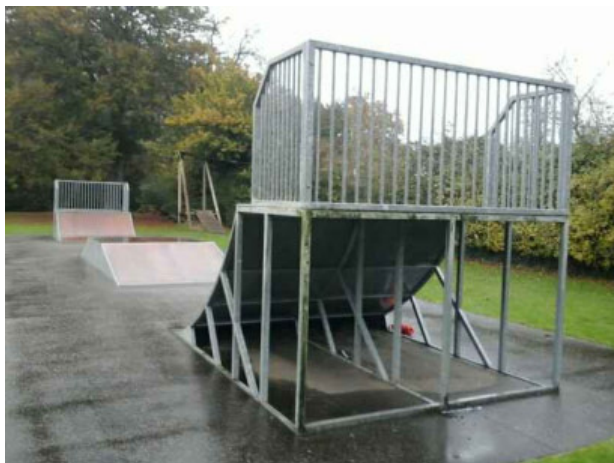
Item: Ancillary Items - Site General
Manufacturer: Owner/Operator

Finding: Signage should be provided as recommended in BS EN 14974; this will include, but not exclusively, the use of the area, a recommendation to wear protective equipment, emergency contact details etc.

Action: Provide signage as recommended by BS EN 14974

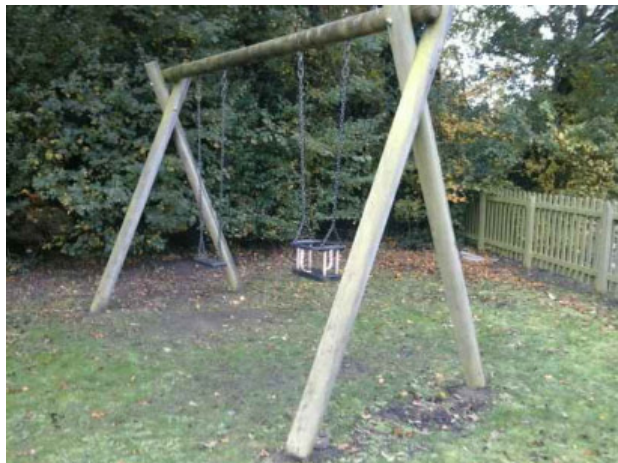
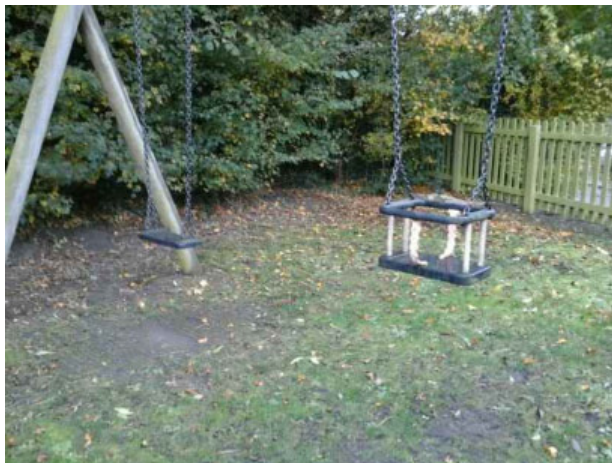
Item: Swings - 1 Bay Mixed Seat, 1 Cradle, 1 Flat
Manufacturer: Adventure Playgrounds

Finding: The use of mixed seats in one bay is not generally recommended but in some circumstances can be justified using risk assessment considering the type and number of users anticipated in the area

Action: Ensure a suitable and sufficient risk assessment has been undertaken

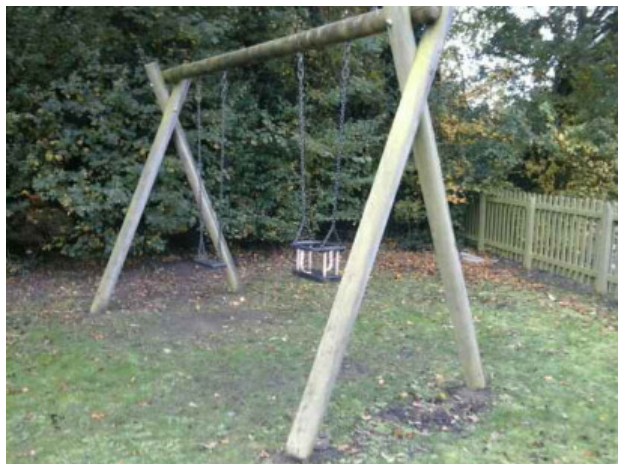
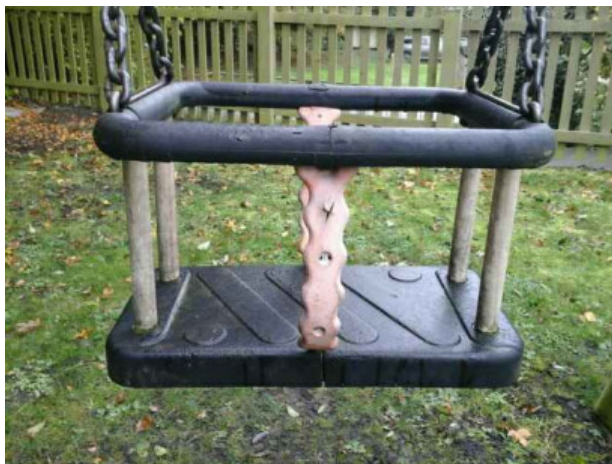
Item: Swings - 1 Bay Mixed Seat, 1 Cradle, 1 Flat
Manufacturer: Adventure Playgrounds
Risk Level: L - Low Risk
Surface: Grass Matrix Tiles

Finding: The seat has minor damage or wear

Action: Monitor for any further deterioration and replace as required

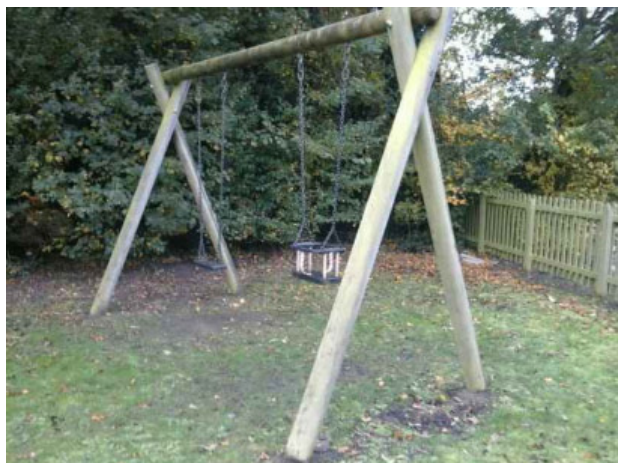
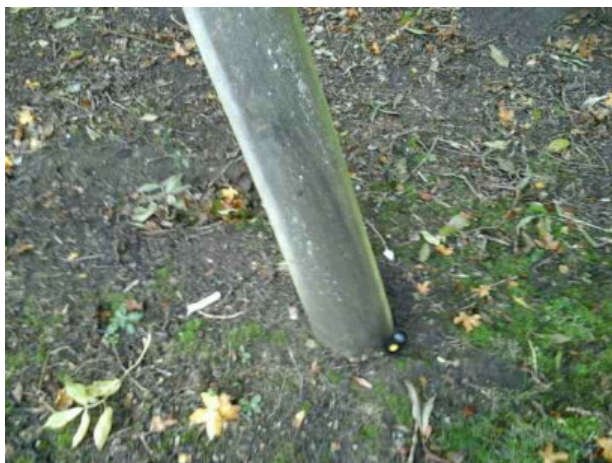
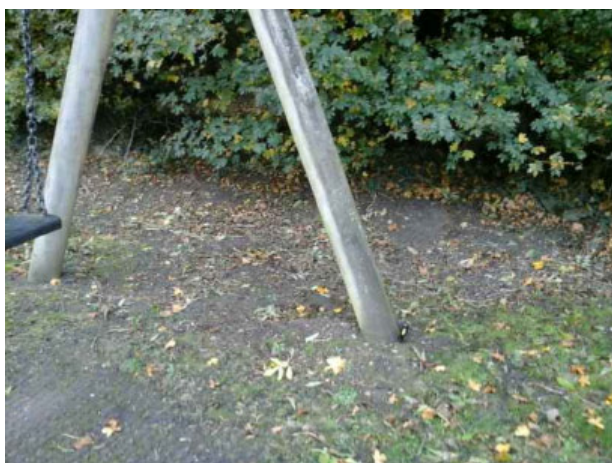
Item: Swings - 1 Bay Mixed Seat, 1 Cradle, 1 Flat **Risk Level:** M - Moderate Risk
Manufacturer: Adventure Playgrounds **Surface:** Grass Matrix Tiles

Finding: The timber on this item has severe rot in a support post

Action: Remove and replace all affected timber sections

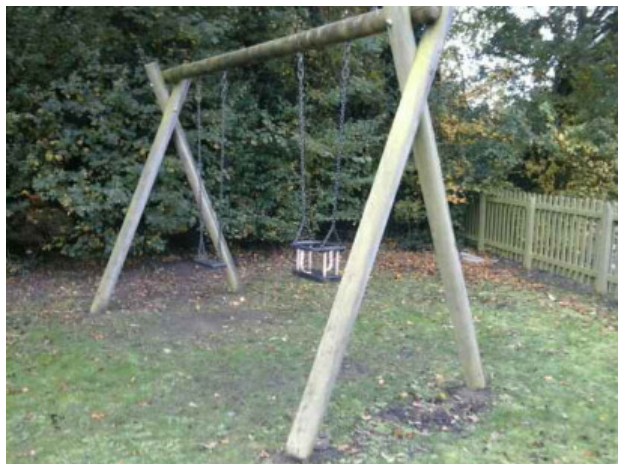
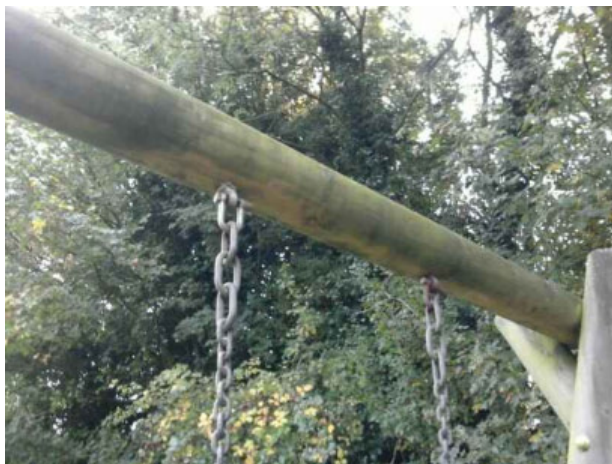
Item: Swings - 1 Bay Mixed Seat, 1 Cradle, 1 Flat
Risk Level: L - Low Risk
Manufacturer: Adventure Playgrounds
Surface: Grass Matrix Tiles

Finding: The bushes are worn or missing
Action: Replace worn or missing bushes

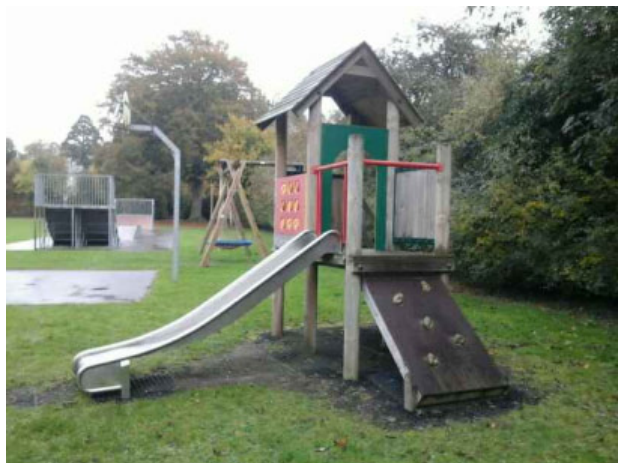
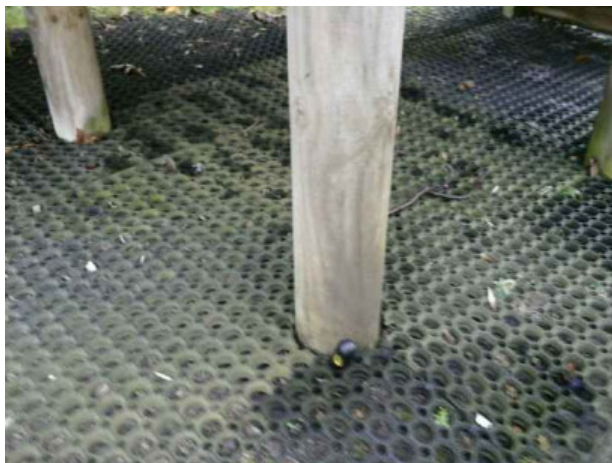
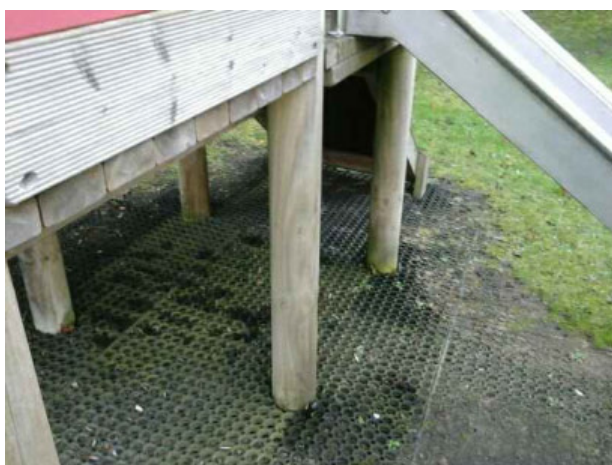
Finding: There is severe rot within a timber support post

Action: Replace all affected timbers

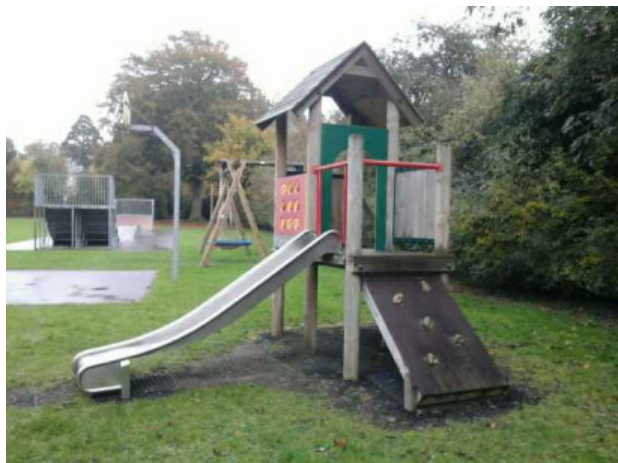
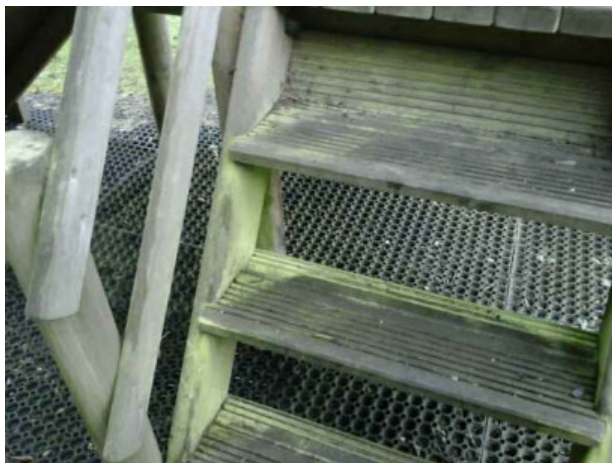
Item: Activity Equipment - Multi Play (Junior)
Manufacturer: Adventure Playgrounds

Finding: There is algae or moss growth on the equipment resulting in slippery conditions

Action: Clean and treat appropriately

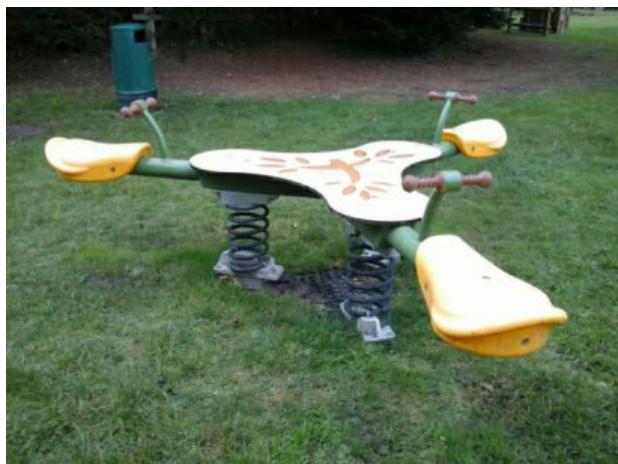
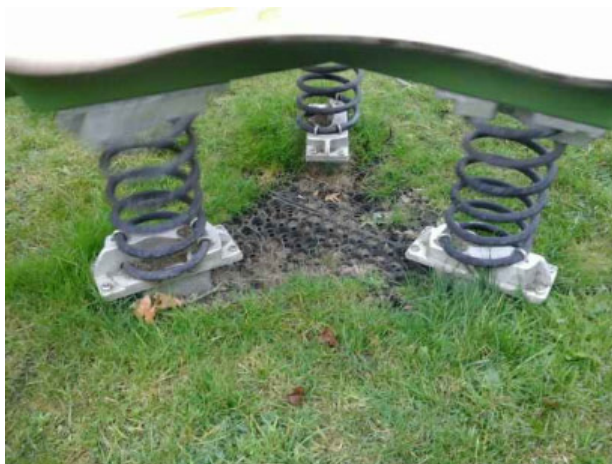
Item: Rocking Equipment - Three Way Springer
Manufacturer: Husson UK

Finding: The surface has subsided in some areas

Action: Monitor for any further deterioration and repair as required

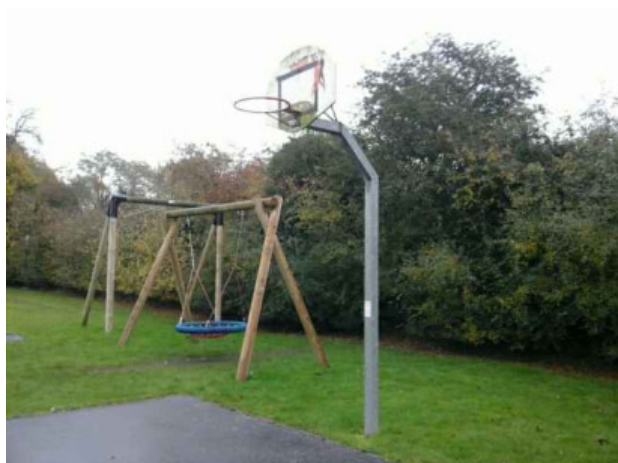
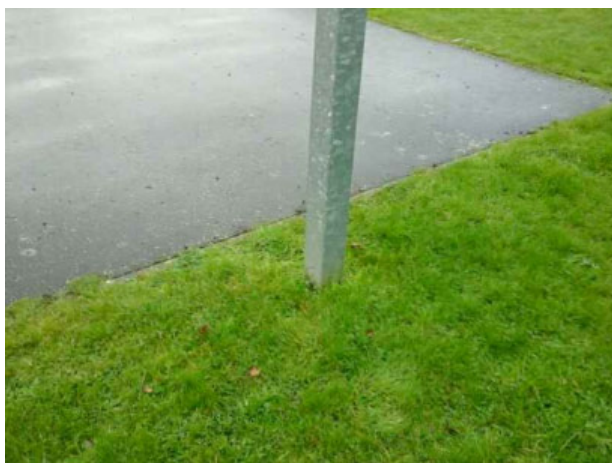
Finding: The item is slightly loose in its foundations

Action: Monitor for any further deterioration and repair as required

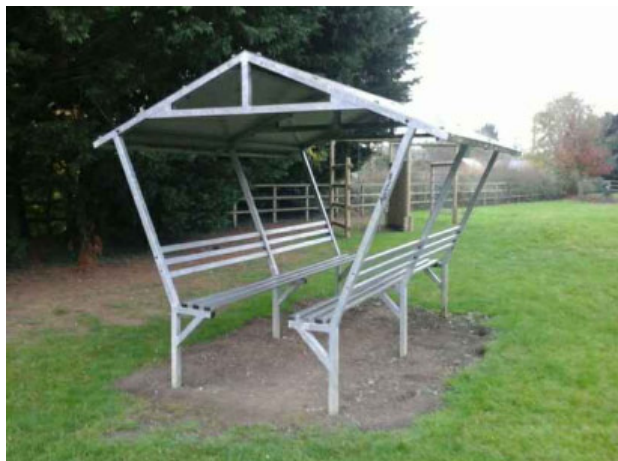
Item: Ancillary Items - Shelter
Manufacturer: Hags SMP

Finding: There is/are bolt cap covers missing or damaged on the item

Action: Replace missing or damaged bolt cap covers

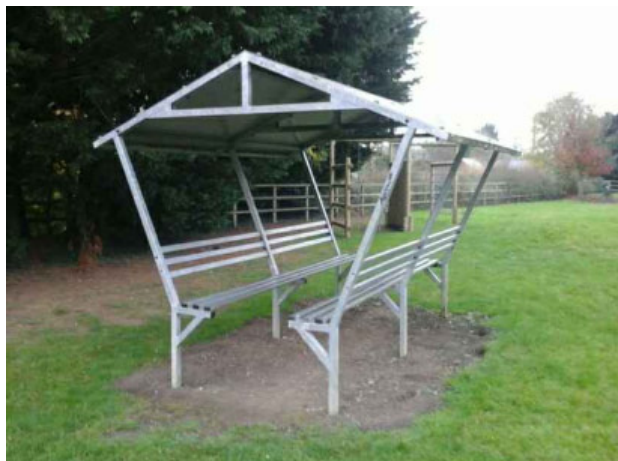
Item: Ancillary Items - Shelter
Manufacturer: Hags SMP

Finding: The paintwork on this item has been damaged or worn exposing the metal underneath which is rusting

Action: Treat any rusting components and repaint

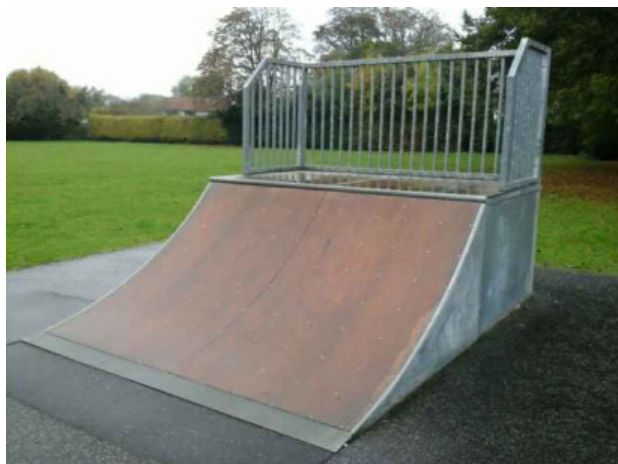
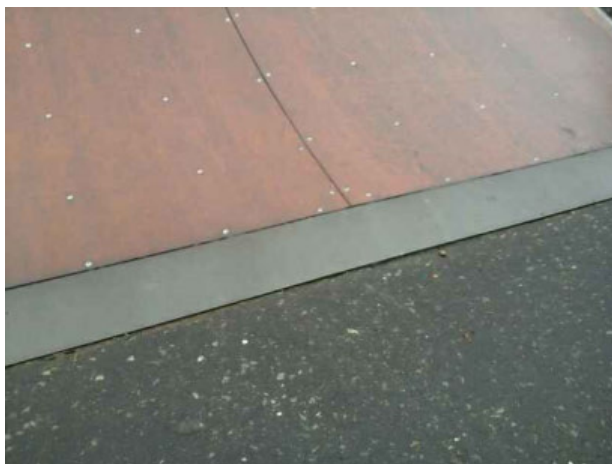
Item: Wheeled Sports - Quarter Pipe
Manufacturer: Not Identified

Finding: The kicker plate protrudes more than 5mm above the surrounding surface level, BS EN 14974 recommends a maximum of 5mm with 3mm preferred

Action: Adjust height to ensure a maximum of 5mm change in level

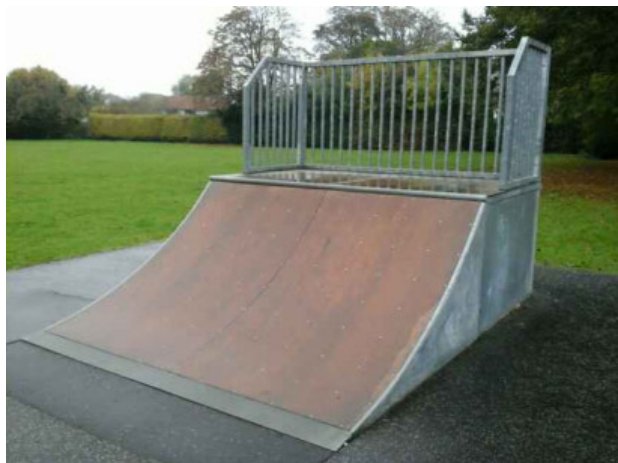
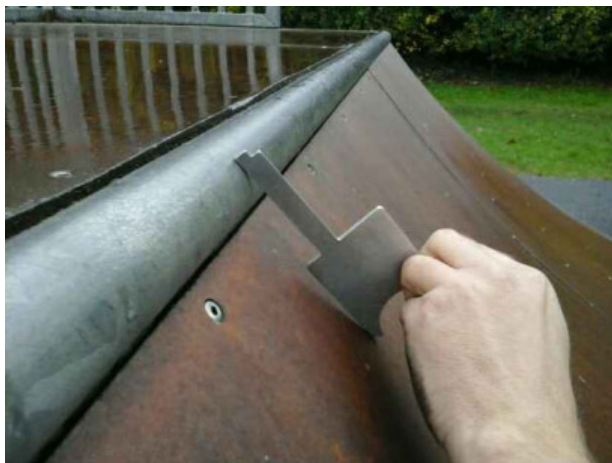
Item: Wheeled Sports - Quarter Pipe
Manufacturer: Not Identified

Finding: The coping projects more than 12mm and fails the requirements of BS EN 14974

Action: Monitor use

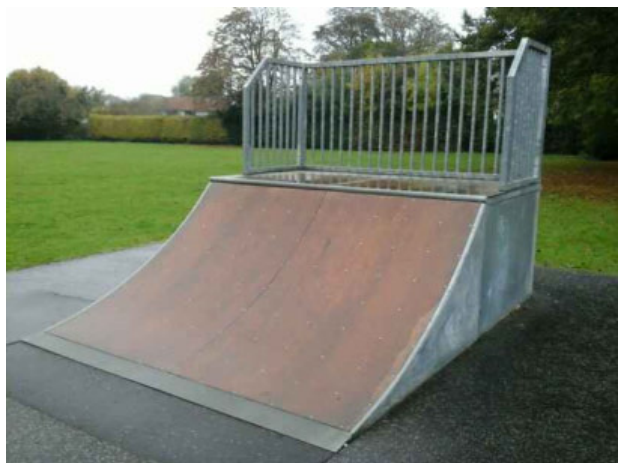
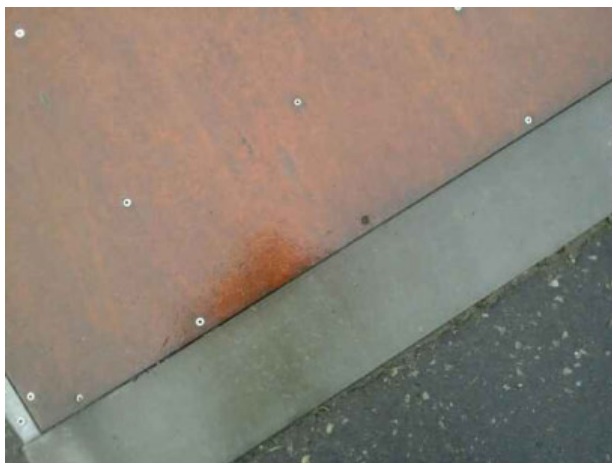
Item: Wheeled Sports - Quarter Pipe
Manufacturer: Not Identified

Finding: There is or are fixings missing on the riding surface

Action: Replace all missing fixings

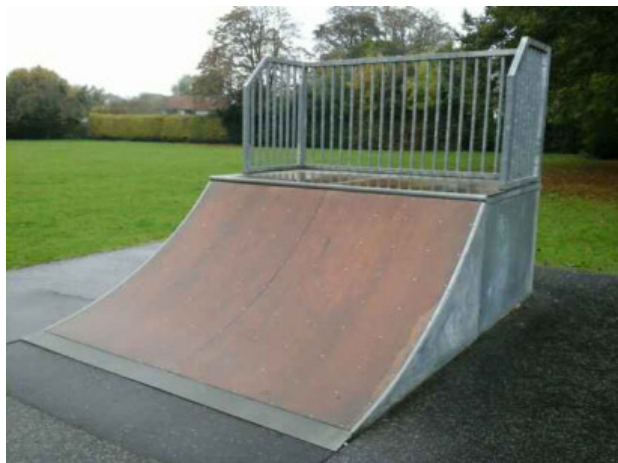
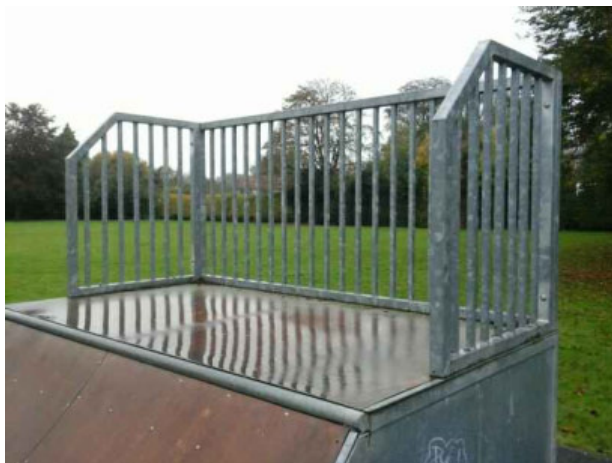
Item: Wheeled Sports - Quarter Pipe
Manufacturer: Not Identified

Finding: The height of the barrier is less than 1200mm and fails the requirements of BS EN 14974
Action: Monitor use

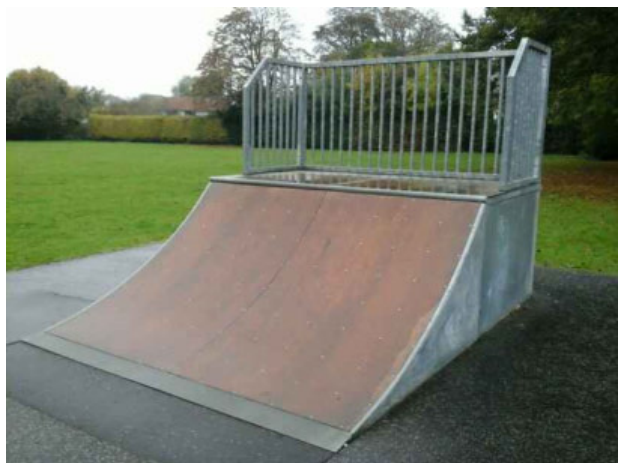
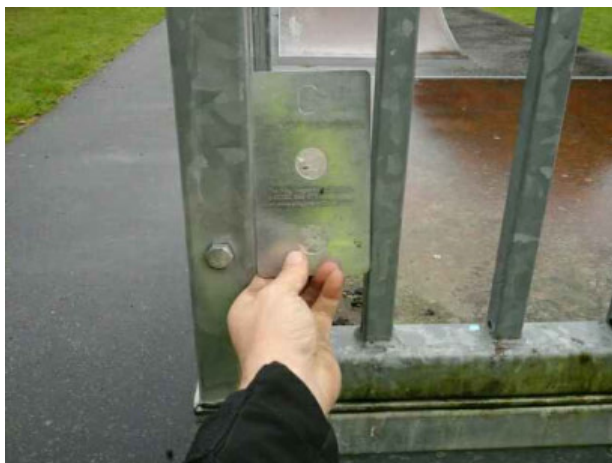
Item: Wheeled Sports - Quarter Pipe
Manufacturer: Not Identified

Finding: The horizontal opening in the barrier is in excess of 89mm and fails the requirements of BS EN 14974
Action: Monitor use

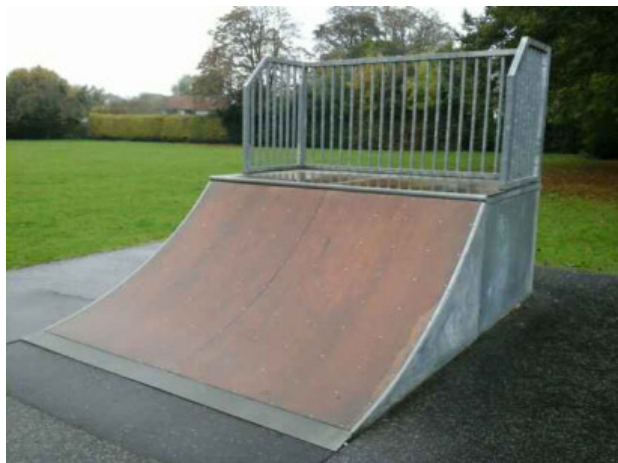
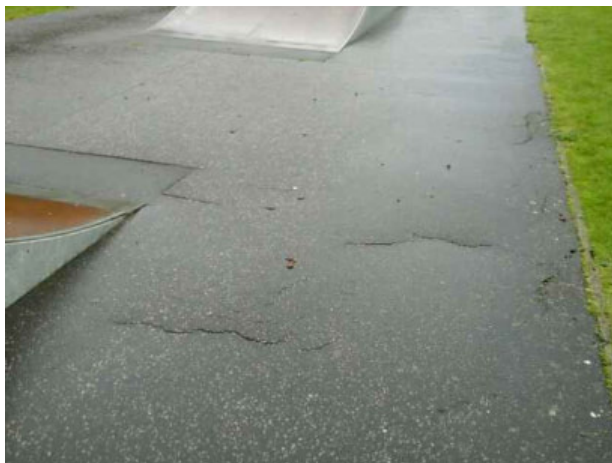
Item: Wheeled Sports - Quarter Pipe
Manufacturer: Not Identified

Finding: There is minor damage to the rolling surface

Action: Monitor for any further deterioration and repair as required

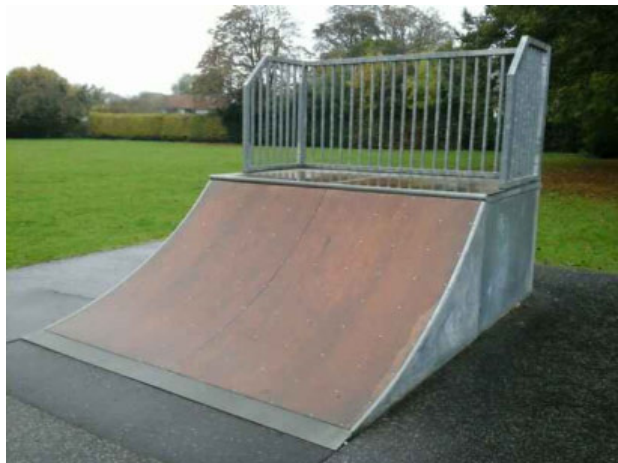
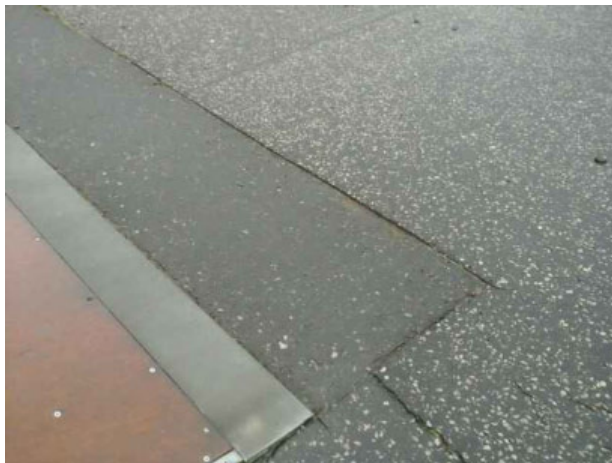
Item: Wheeled Sports - Quarter Pipe
Manufacturer: Not Identified

Finding: There is vertical height difference on the rolling surface in front of the kicker plate of the item

Action: Repair to provide a level transition

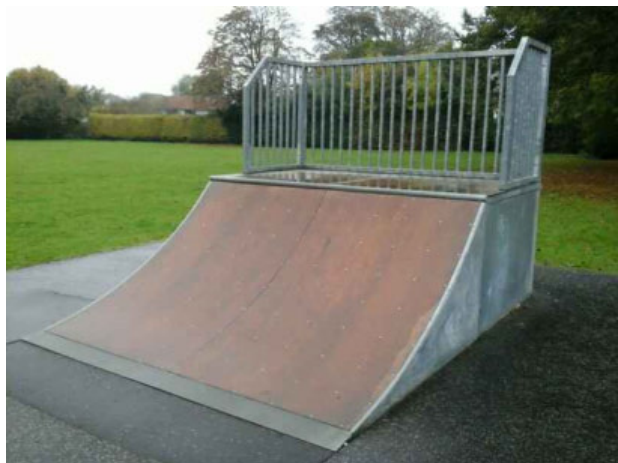
Item: Wheeled Sports - Quarter Pipe
Manufacturer: Not Identified

Finding: There is algae or moss growth on the surface resulting in slippery conditions
Action: Clean and treat appropriately

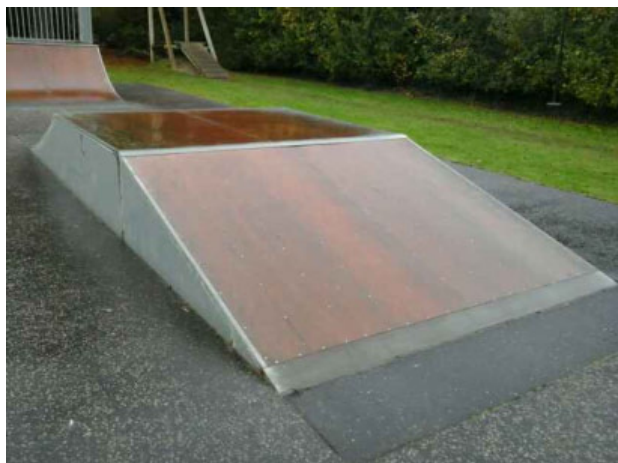
Item: Wheeled Sports - Fun Box
Manufacturer: Not Identified

Finding: There is algae or moss growth on the surface resulting in slippery conditions
Action: Clean and treat appropriately

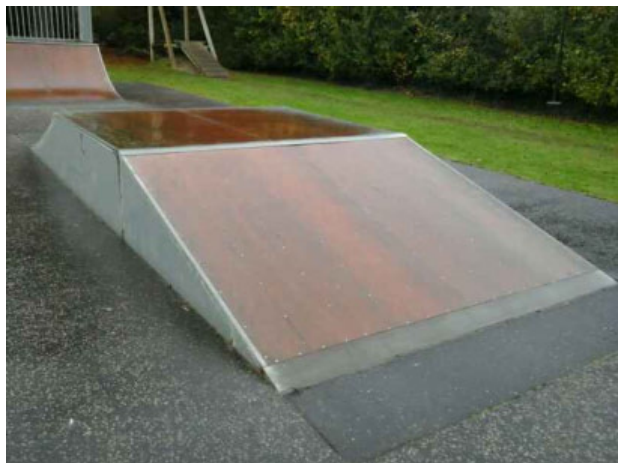
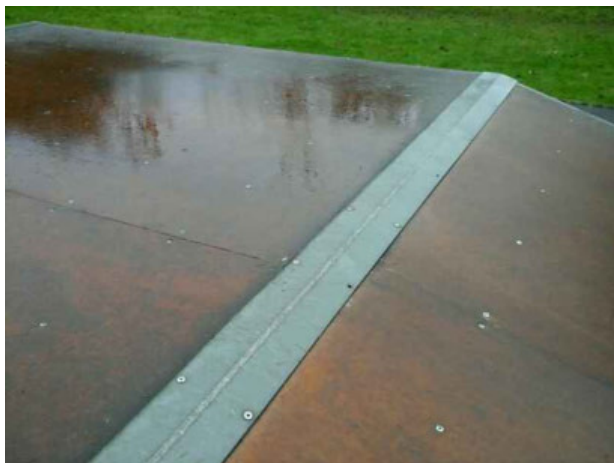
Finding: There is or are fixings missing on the item

Action: Replace all missing fixings

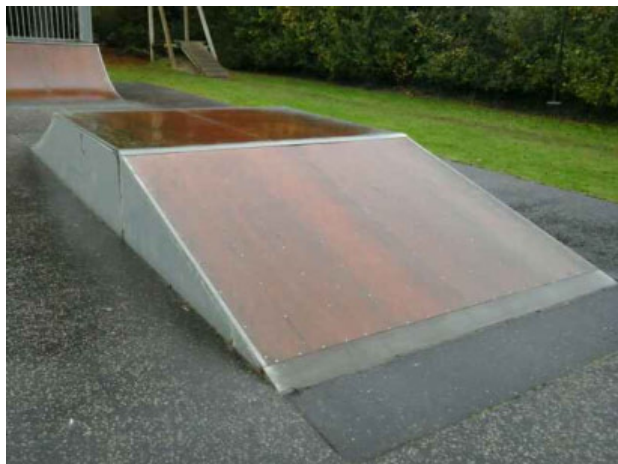
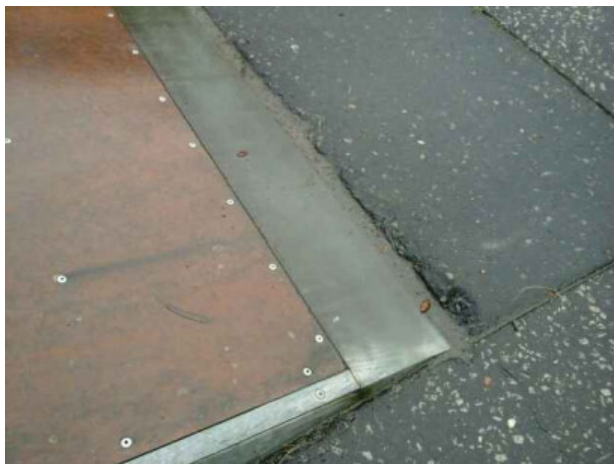
Finding: There is a large gap at the foot of ramp with a vertical height difference exceeding 5 mm

Action: Repair the surface to level

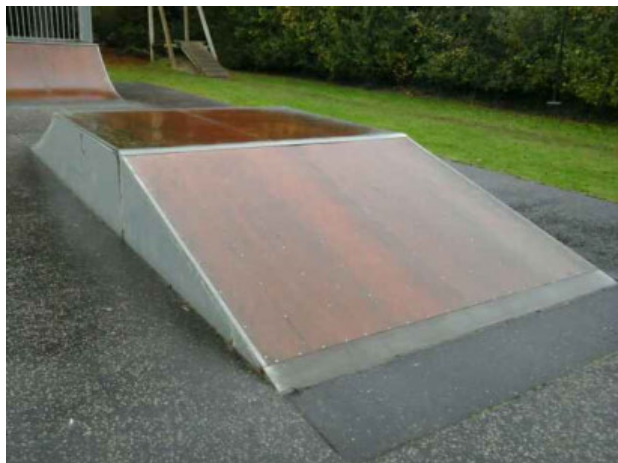
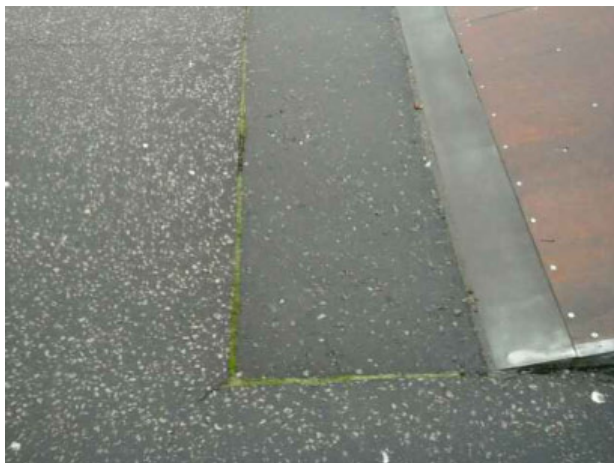
Finding: There are large gaps within the rolling surface **Action:** Repair the surface

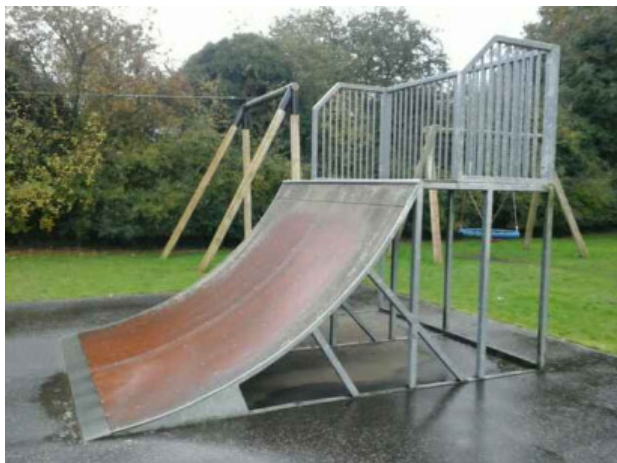
Finding: There is algae or moss growth on the surface resulting in slippery conditions
Action: Clean and treat appropriately

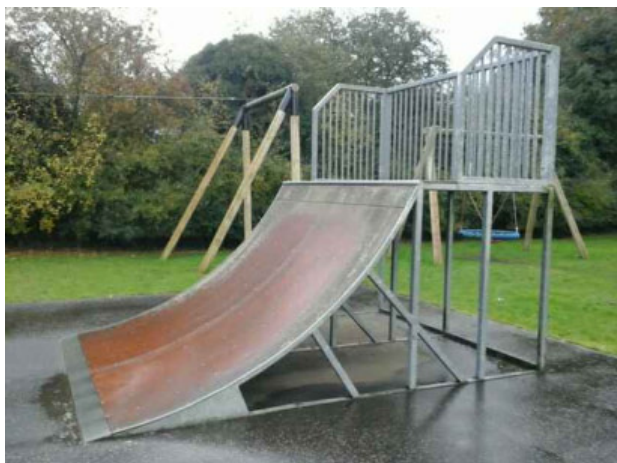
Finding: The height of the barrier is less than 1200mm and fails the requirements of BS EN 14974
Action: Monitor use

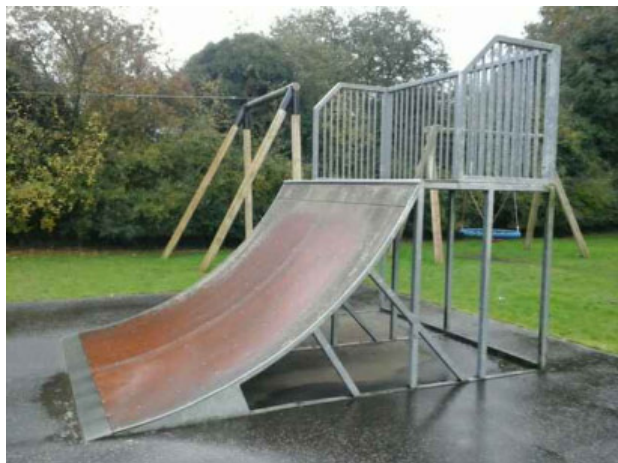
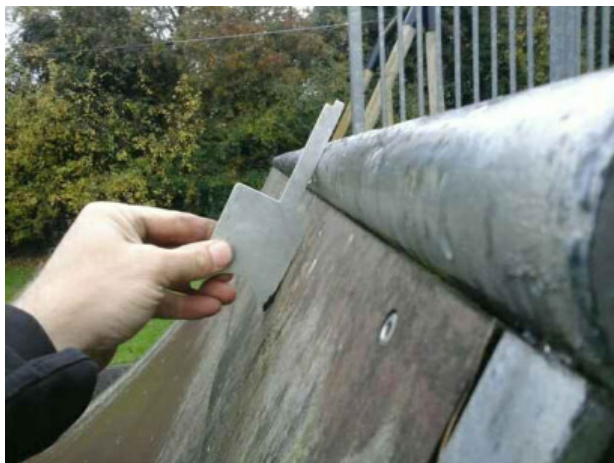
Finding: The coping projects more than 12mm and fails the requirements of BS EN 14974

Action: Monitor use

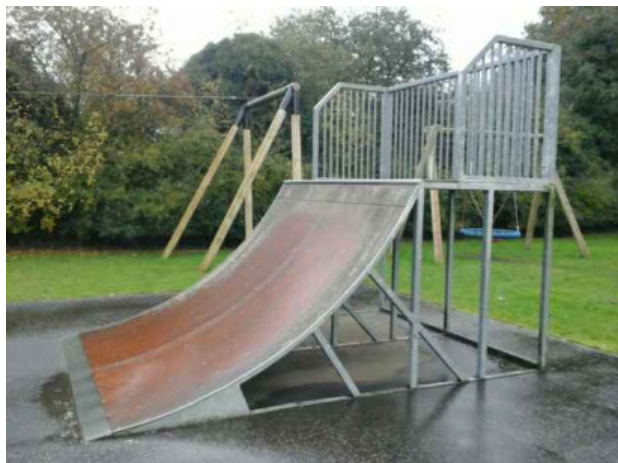
Finding: The kicker plate protrudes more than 5mm above the surrounding surface level, BS EN 14974 recommends a maximum of 5mm with 3mm preferred

Action: Adjust height to ensure a maximum of 5mm change in level

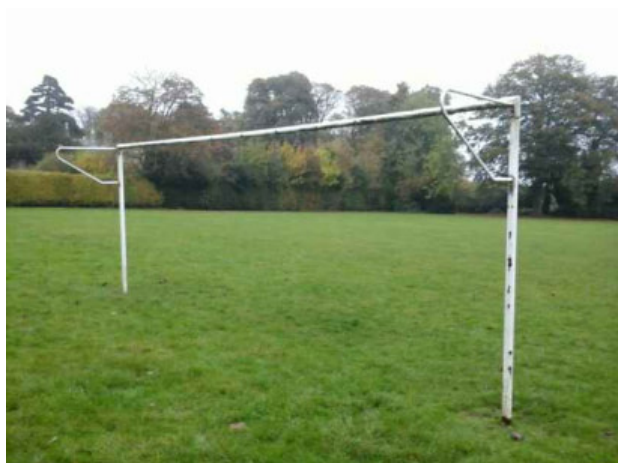
Finding: The paintwork on this item has been damaged or worn exposing the metal underneath which is rusting

Action: Treat any rusting components and repaint

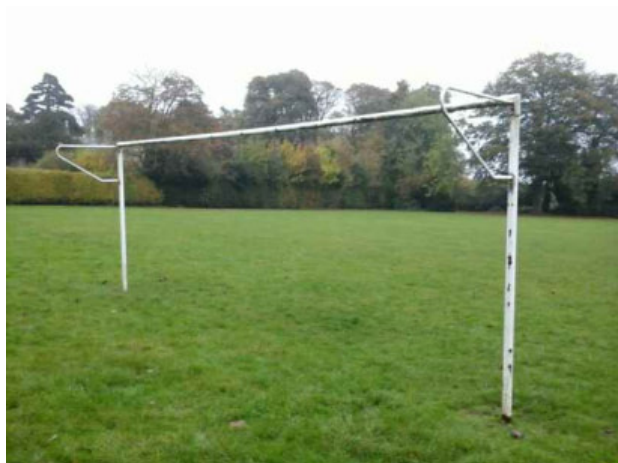
Finding: The goal net fixings are missing

Action: Replace the missing fixings

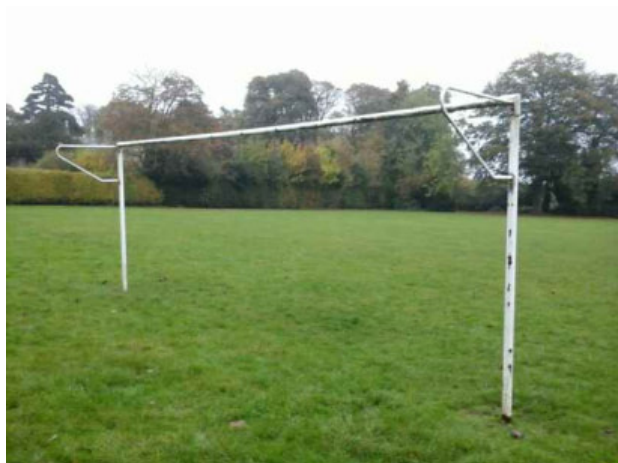
Finding: A corner bracket is missing

Action: Replace as required

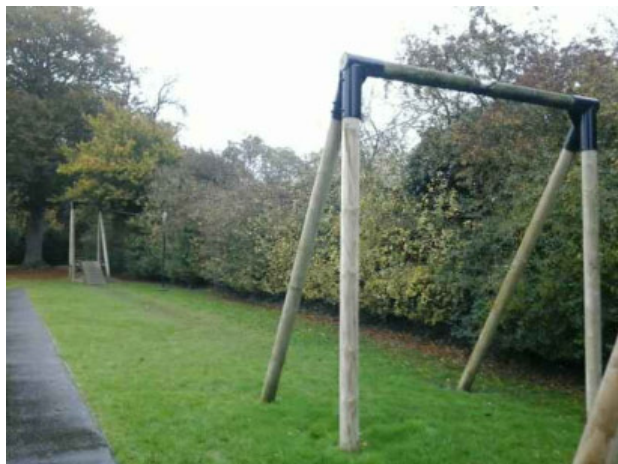
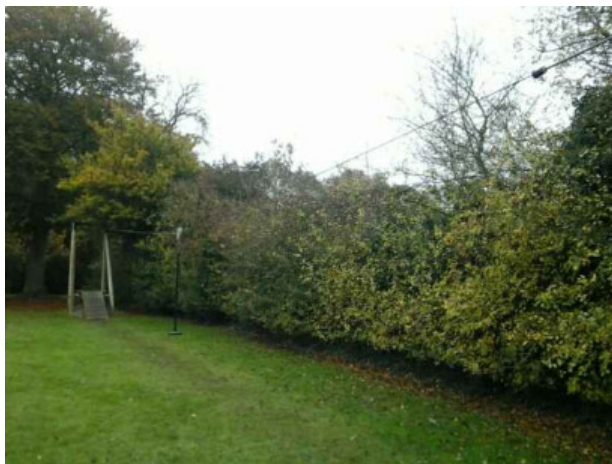
Finding: We recommend that the main cable is thoroughly inspected at least once every 2 years this; will involve either removing the cable or gaining access by ladders and/or steps to inspect for damage or internal rusting, this will help to ensure the continued safe use of the equipment

Action: Inspect cable every 24 months

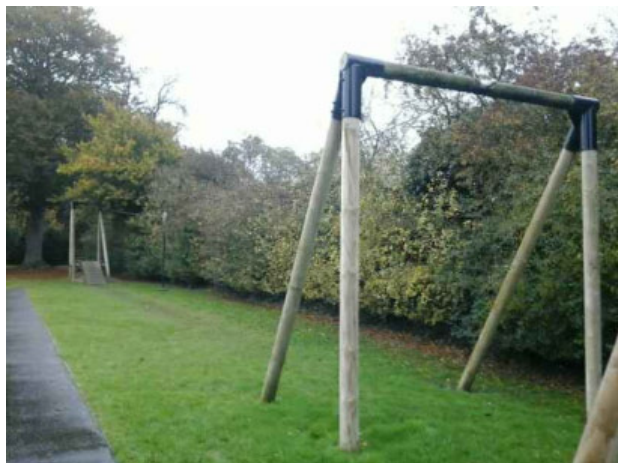
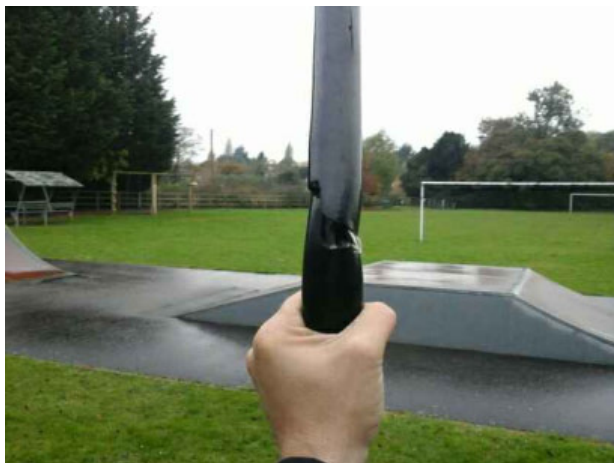
Finding: The seat suspension cover has been damaged

Action: Monitor for any further deterioration and replace as required

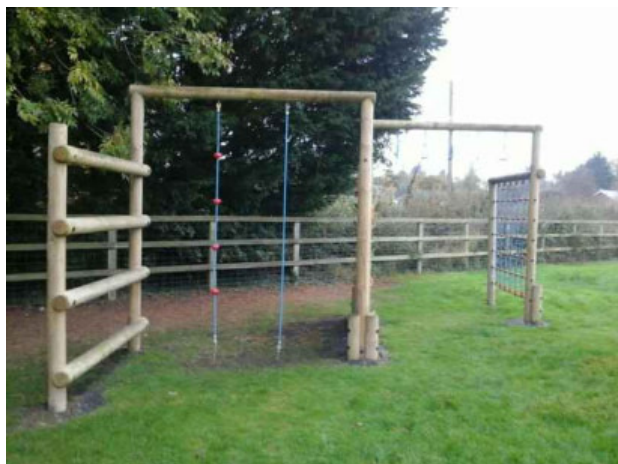
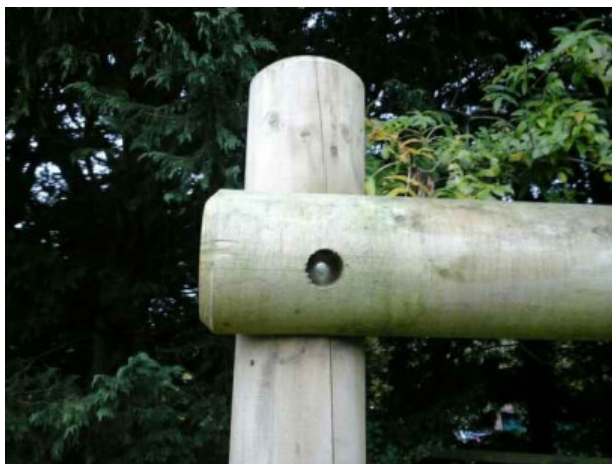
Finding: There is/are bolt cap covers missing or damaged on the item

Action: Replace missing or damaged bolt cap covers
