Annual Inspection

Wreningham Parish Council

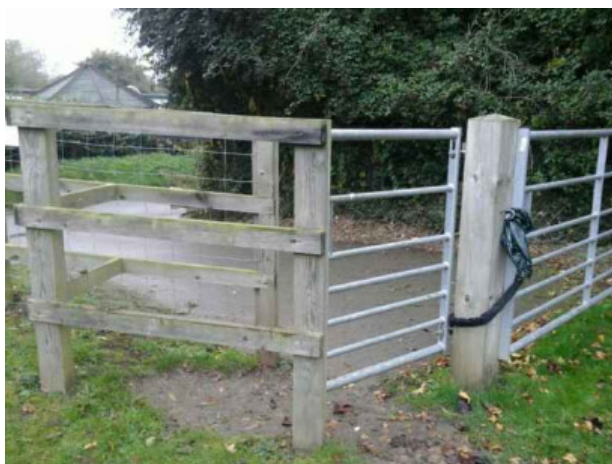
The opening between the gate and the post is less than 12mm and could trap users fingers - Adjust gate to ensure a 12mm opening all around

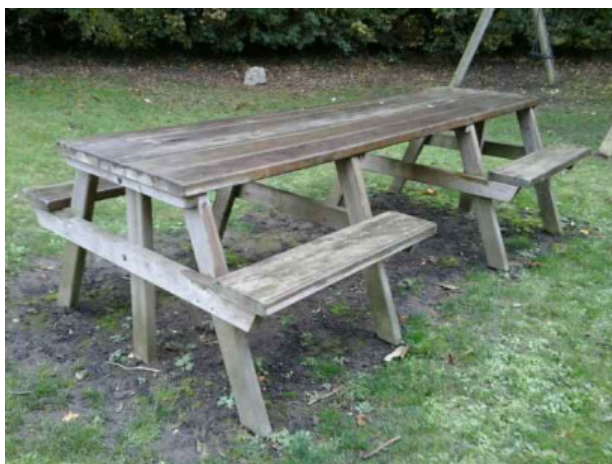
The area around the bench has eroded and may become slippery - Reinststate eroded area

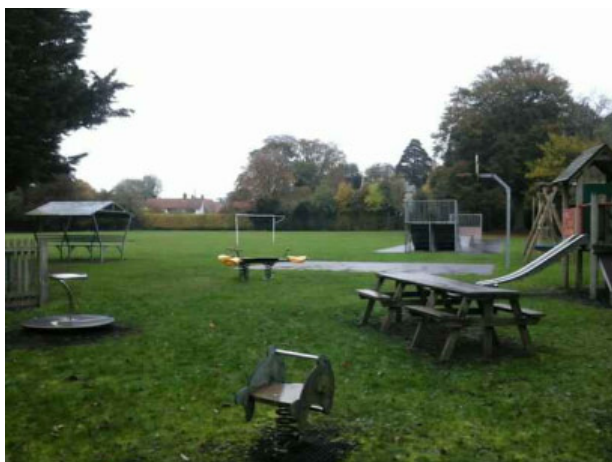
There are a number of molehills within the area and these may present unforeseen hazards for users - Remove moles by appropriate means, reinstate surfaces to level and maintain the area

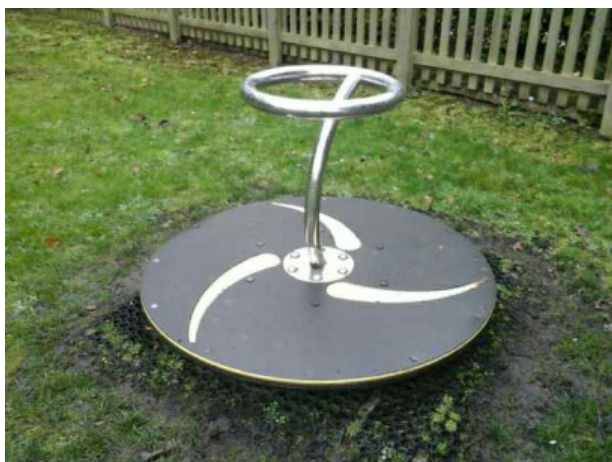
There are gaps opening between the grass mat tiles - Reinstate surface

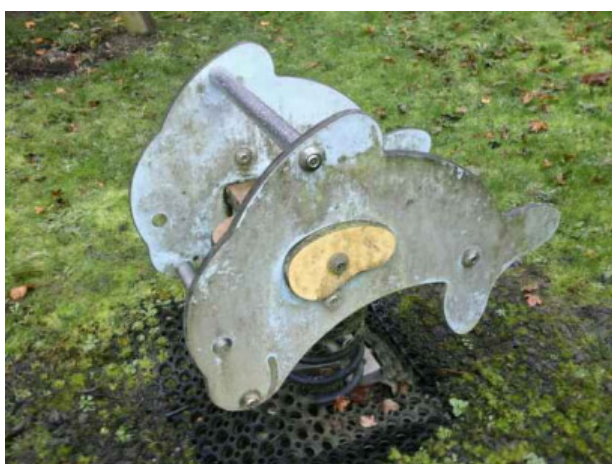
There is algae or moss growth on the item - Clean and treat appropriately

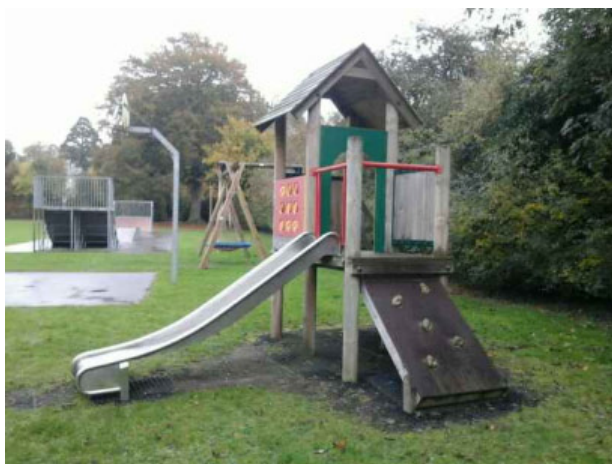
The unit is easily accessible and has an opening in the barrier to steep play elements in excess of 500mm - Monitor use

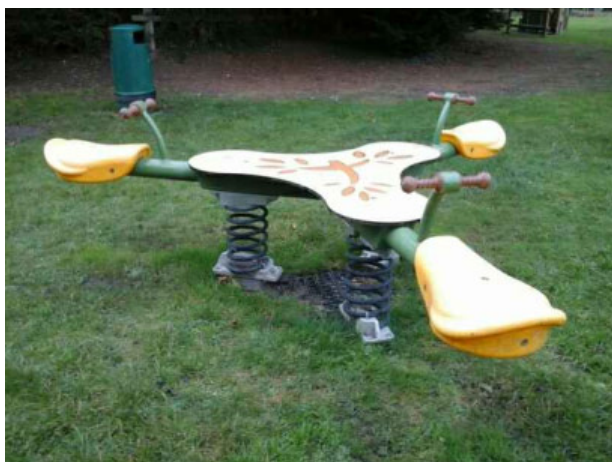
The surface has subsided in some areas - Monitor for any further deterioration and repair as required

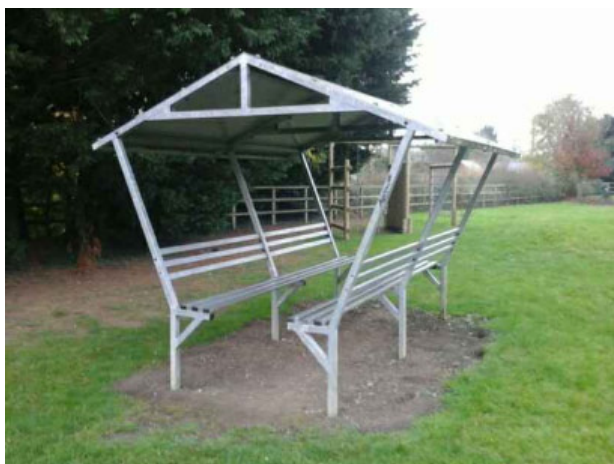
The area around the shelter has eroded and may become slippery - Reinstate eroded area

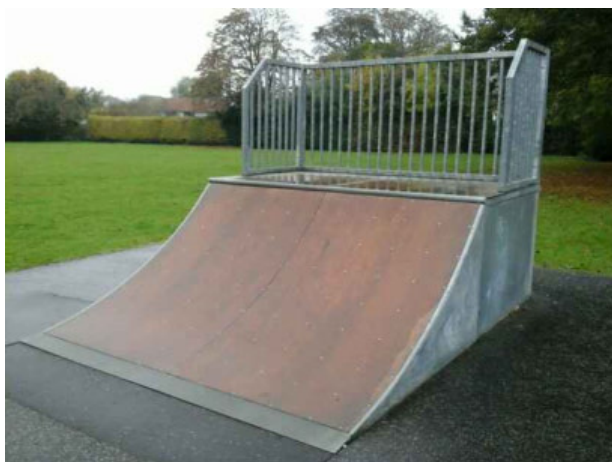
The kicker plate protrudes more than 5mm above the surrounding surface level, BS EN 14974 recommends a maximum of 5mm with 3mm preferred - Adjust height to ensure a maximum of 5mm change in level

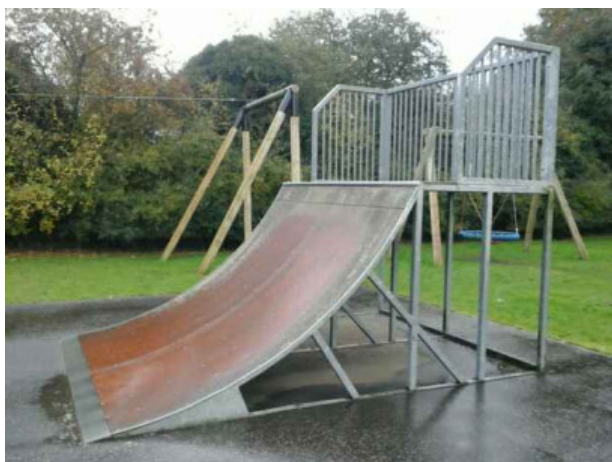
There is algae or moss growth on the surface resulting in slippery conditions - Clean and treat appropriately

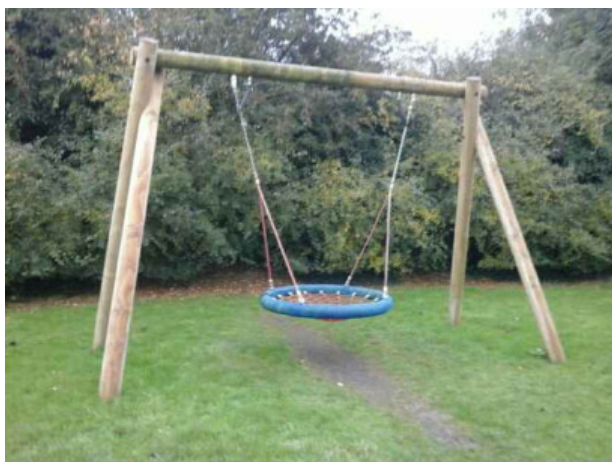
The grass mats are silted up and the soil is compacted; this may have an effect on the impact absorbing properties of the surface - Lift and relay mats or test impact absorbing properties to ensure the correct surface qualities are maintained for the equipment

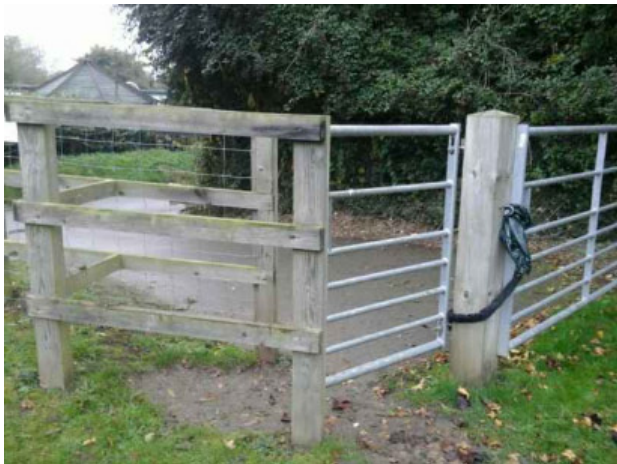
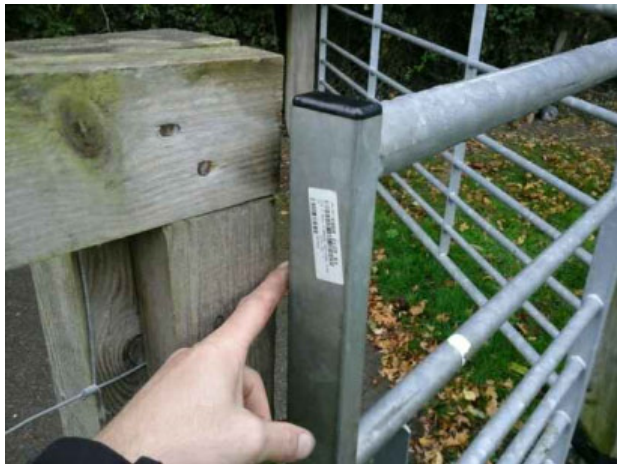
Finding:	The opening between the gate and the post is less than 12mm and could trap users fingers		Action: Adjust gate to ensure a 12mm opening all around

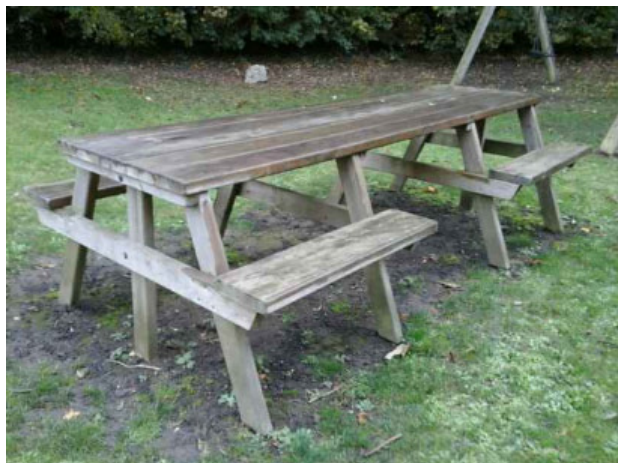
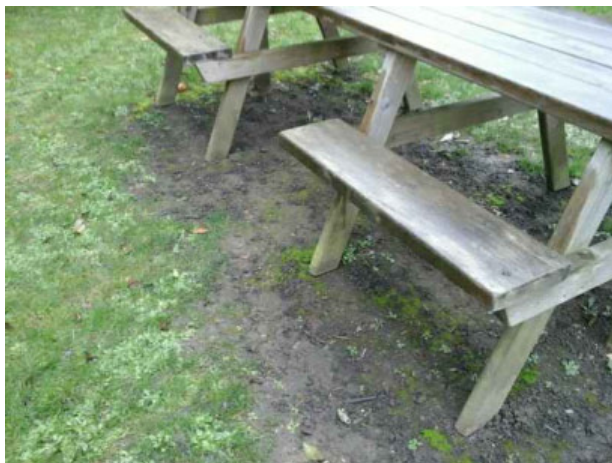
Finding: The area around the bench has eroded and may become slippery

Action: Reinstall eroded area

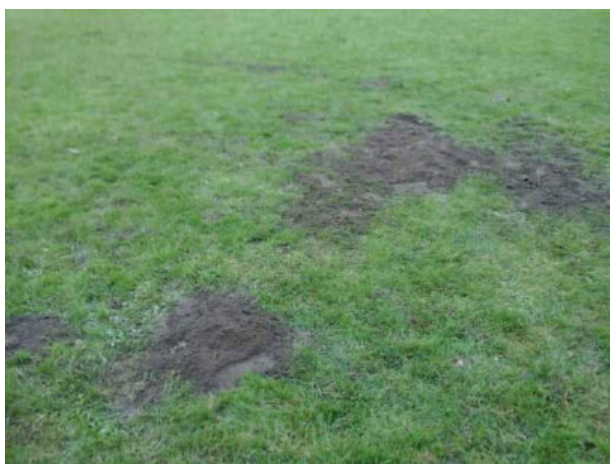
Finding: There are a number of molehills within the area and these may present unforeseen hazards for users

Action: Remove moles by appropriate means, reinstate surfaces to level and maintain the area

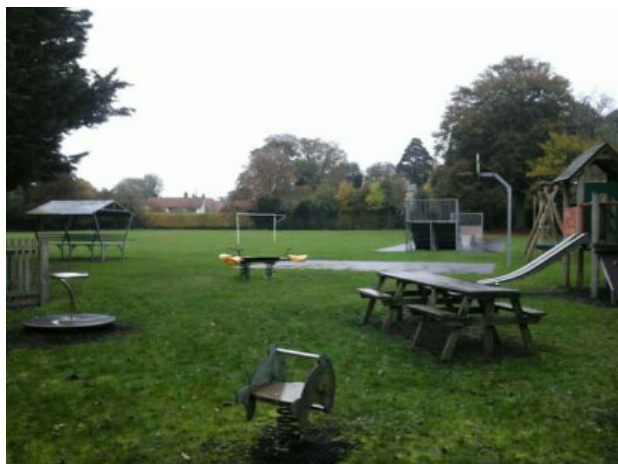
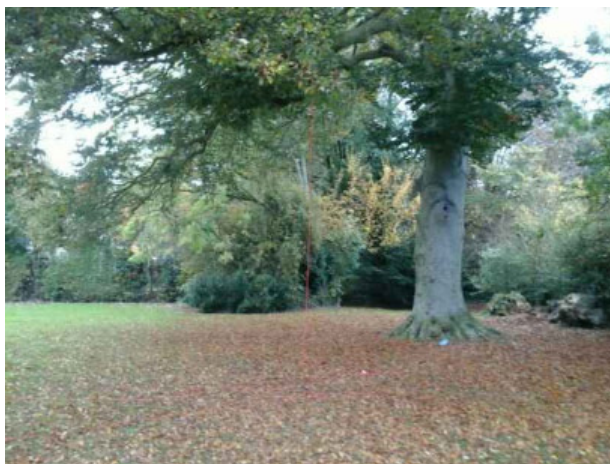
Finding: There is a rope swing attached to the tree

Action: We advise that this is removed immediately

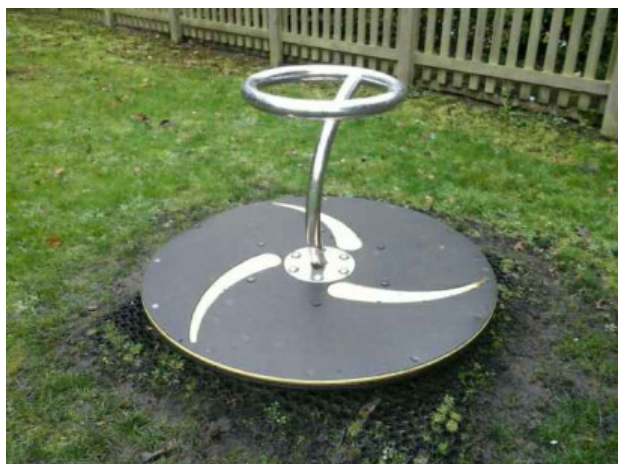
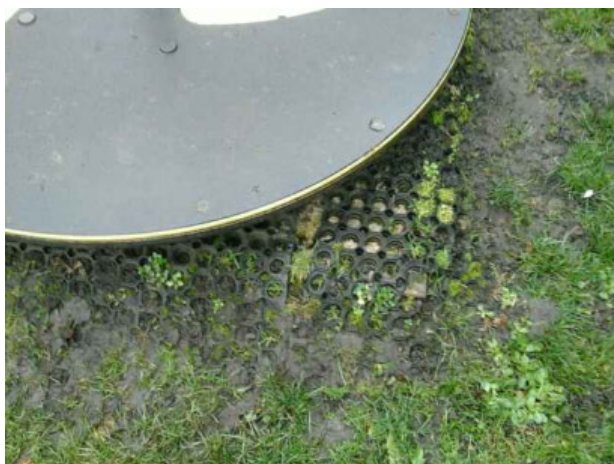
Finding: There are gaps opening between the grass mat tiles

Action: Reinstate surface

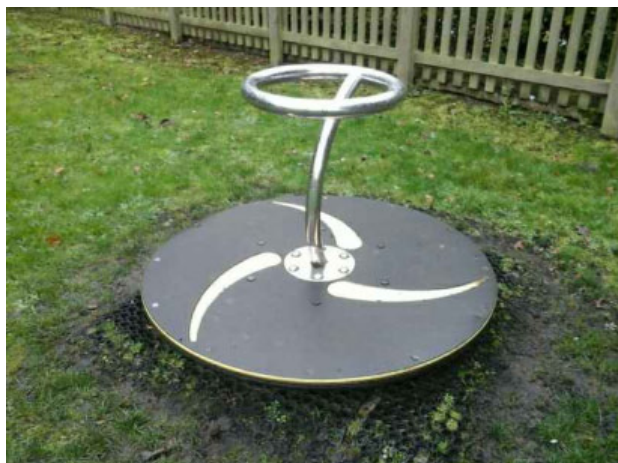
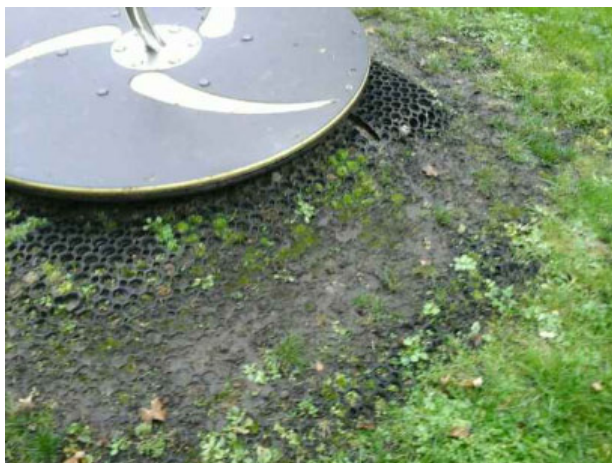
Finding: The grass mats are silted up and the soil is compacted; this may have an effect on the impact absorbing properties of the surface

Action: Lift and relay mats or test impact absorbing properties to ensure the correct surface qualities are maintained for the equipment

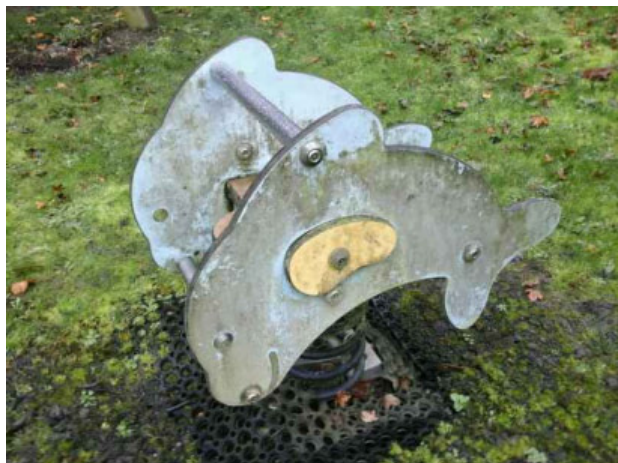
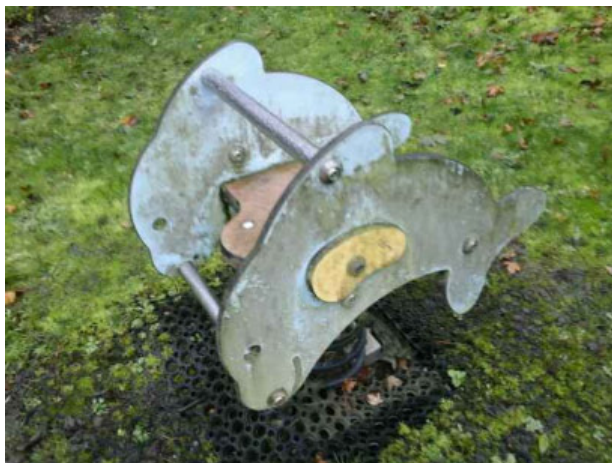
Finding: There is algae or moss growth on the item

Action: Clean and treat appropriately

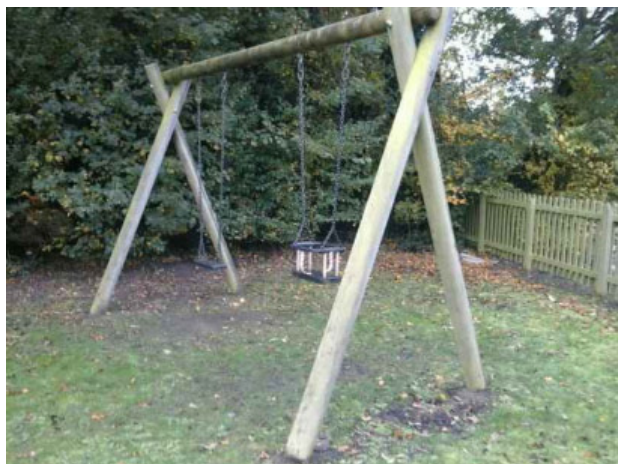
Finding: The grass mats are silted up and the soil is compacted; this may have an effect on the impact absorbing properties of the surface
Action: Lift and relay mats or test impact absorbing properties to ensure the correct surface qualities are maintained for the equipment

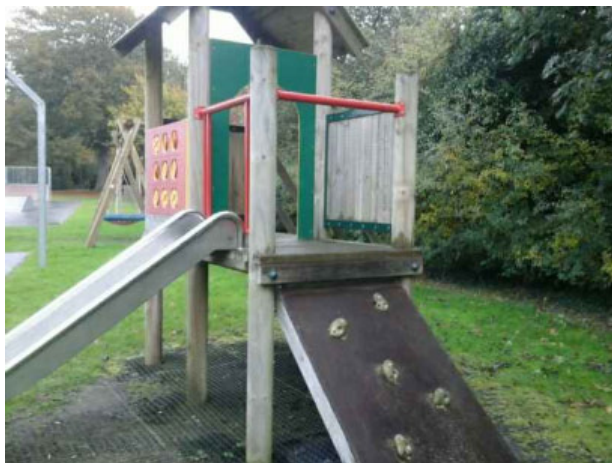
Finding: The unit is easily accessible and has an opening in the barrier to steep play elements in excess of 500mm

Action: Monitor use

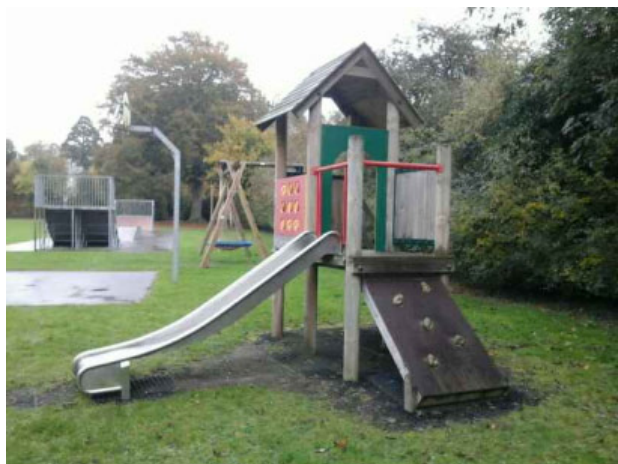
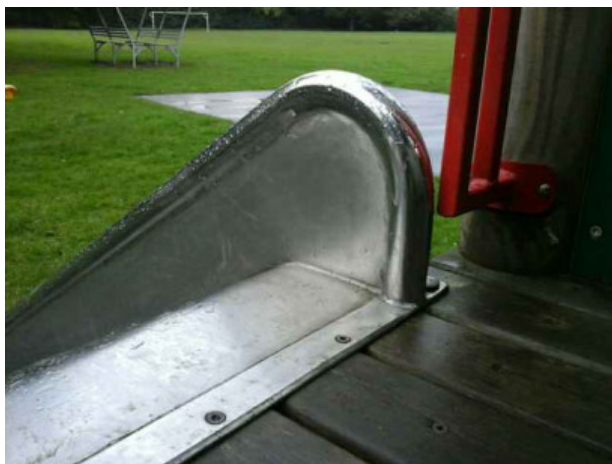
Finding: There is a toggle entrapment at the top of the slide

Action: Monitor Use

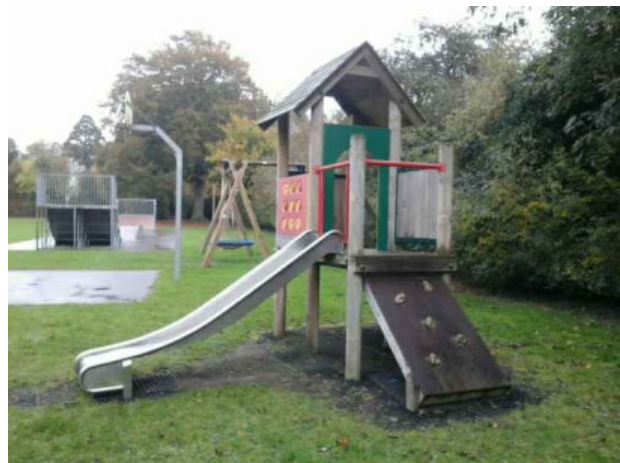
Finding: The grass mats are silted up and the soil is compacted; this may have an effect on the impact absorbing properties of the surface

Action: Lift and relay mats or test impact absorbing properties to ensure the correct surface qualities are maintained for the equipment

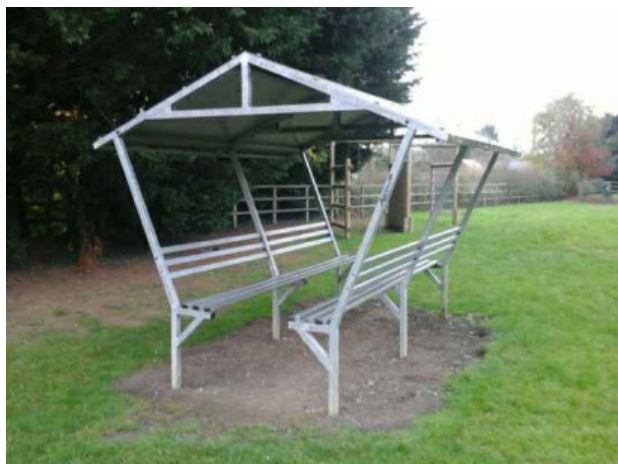
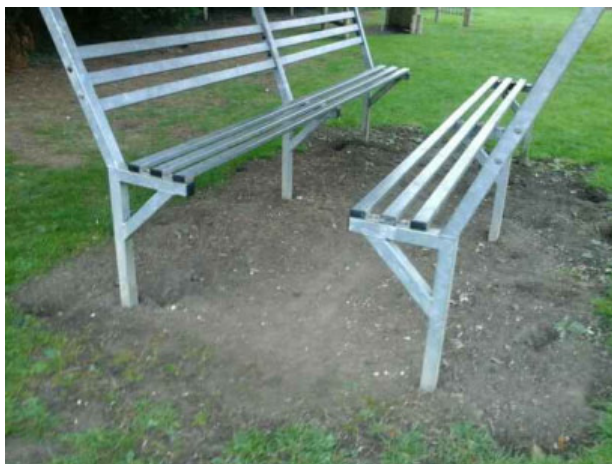
Finding: The area around the shelter has eroded and may become slippery

Action: Reinstate eroded area

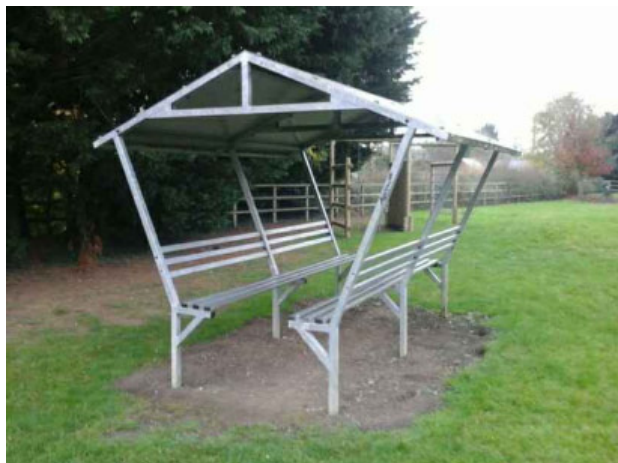
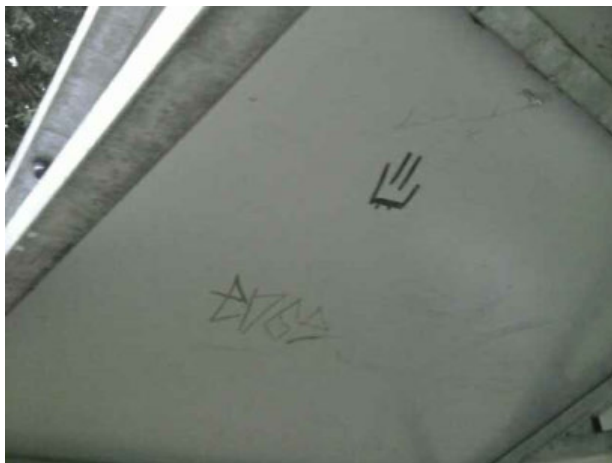
Finding: There is some graffiti present

Action: Remove the graffiti

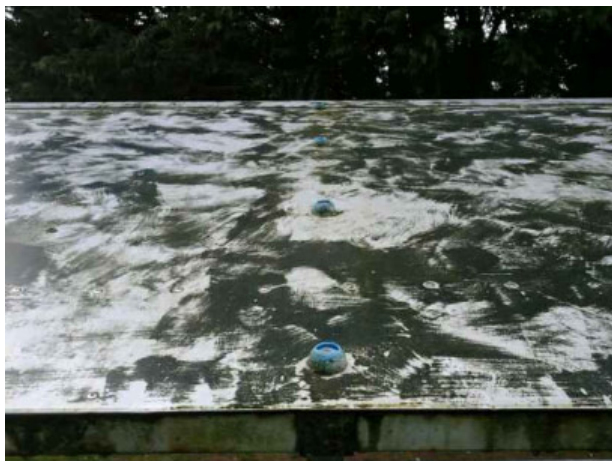
Finding: There is/are bolt cap covers missing or damaged on the item

Action: Replace missing or damaged bolt cap covers

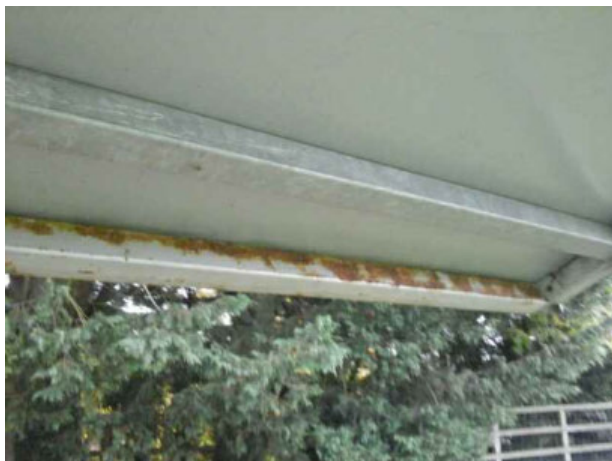
Finding: The paintwork on this item has been damaged or worn exposing the metal underneath which is rusting

Action: Treat any rusting components and repaint

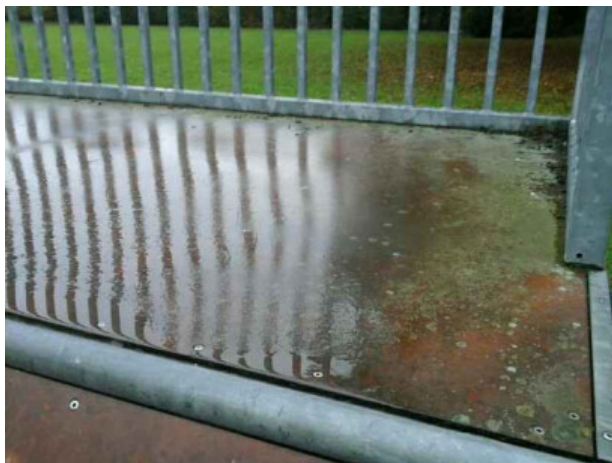
Finding: There is algae or moss growth on the surface resulting in slippery conditions
Action: Clean and treat appropriately

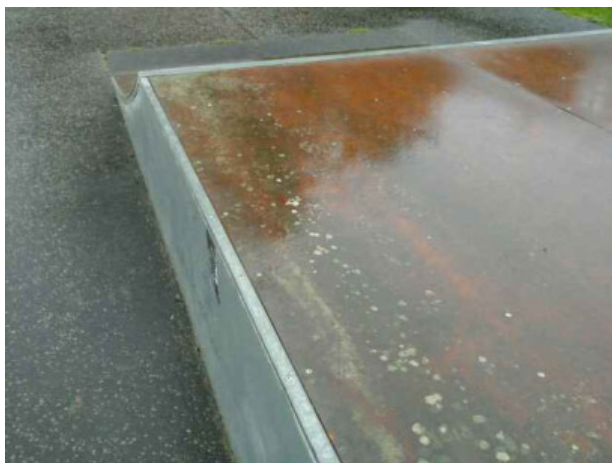
Finding: There is algae or moss growth on the surface resulting in slippery conditions
Action: Clean and treat appropriately

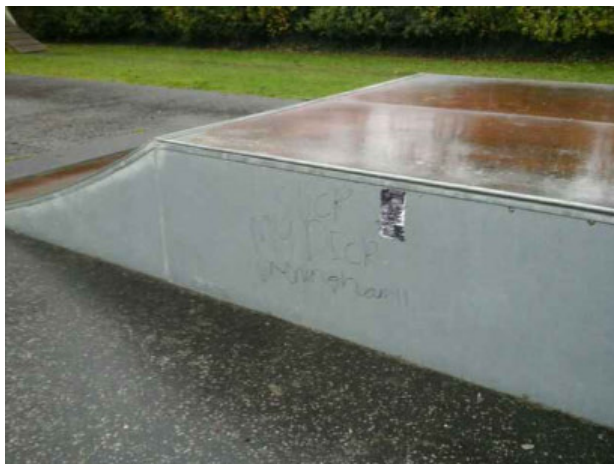
Finding: There is offensive graffiti present **Action:** Remove as soon as practicable

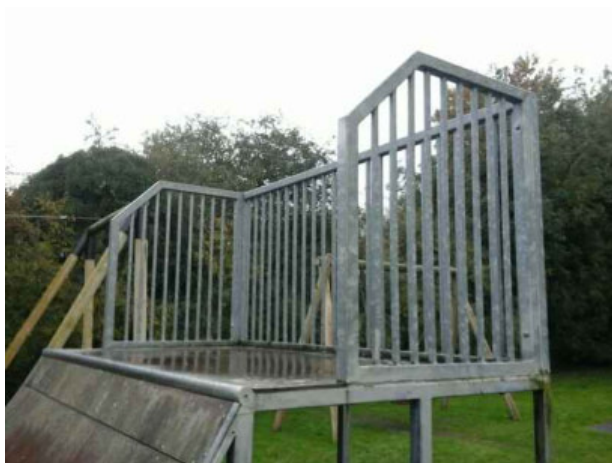
Finding: The height of the barrier is less than 1200mm and fails the requirements of BS EN 14974
Action: Monitor use

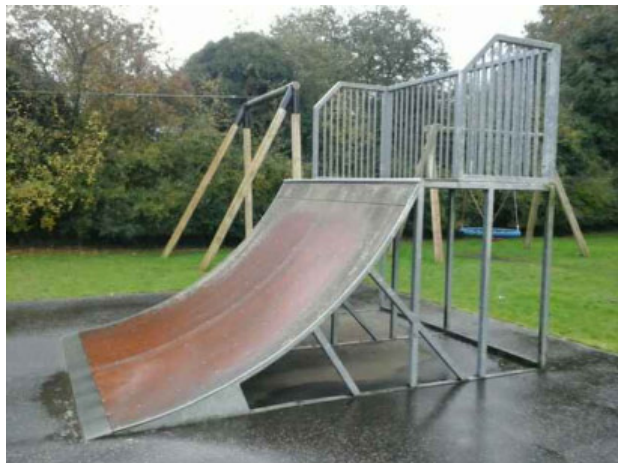
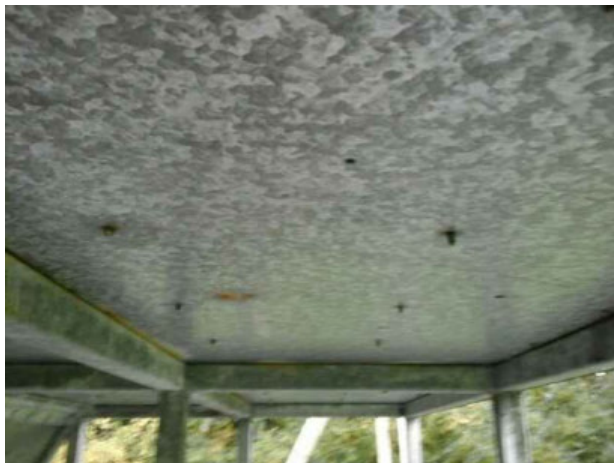
Finding: There are sharp protrusions beneath the item

Action: Remove the sharp protrusions

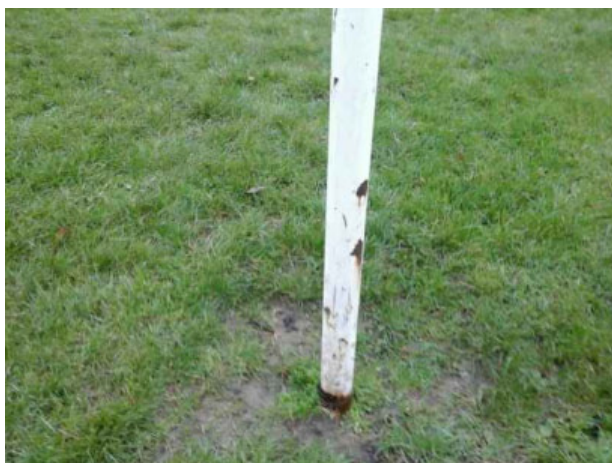
Finding: The paintwork on this item has been damaged or worn exposing the metal underneath which is rusting

Action: Treat any rusting components and repaint

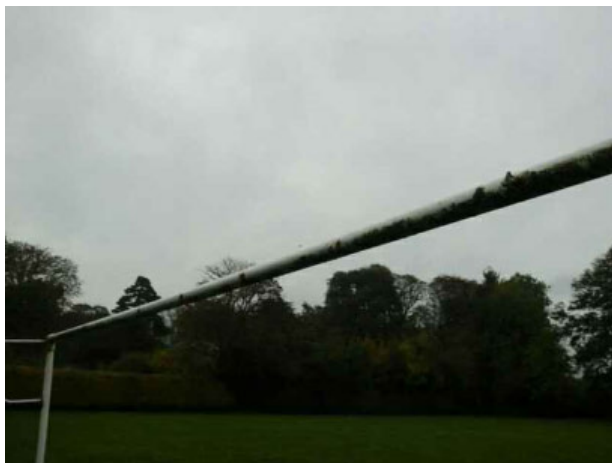
Finding: The goal net fixings are missing

Action: Replace the missing fixings

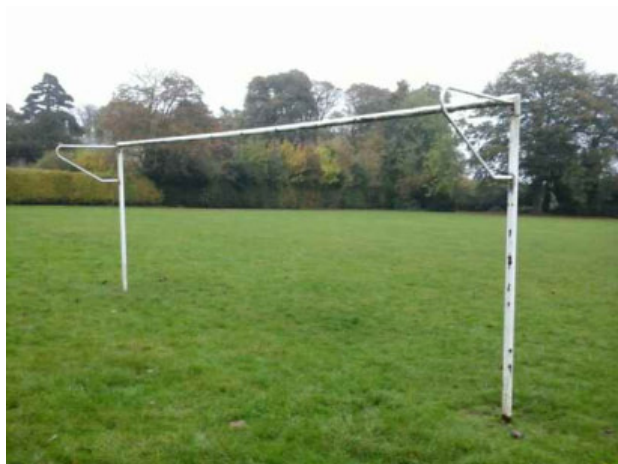
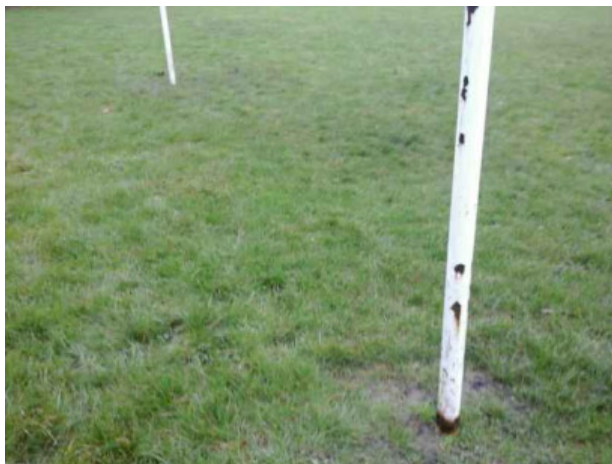
Finding: The goals are not secured into the sockets

Action: Secure the goals against any unauthorised removal

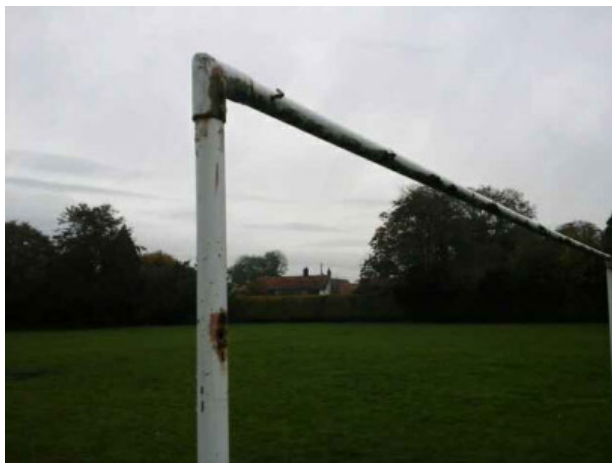
Finding: A corner bracket is missing

Action: Replace as required

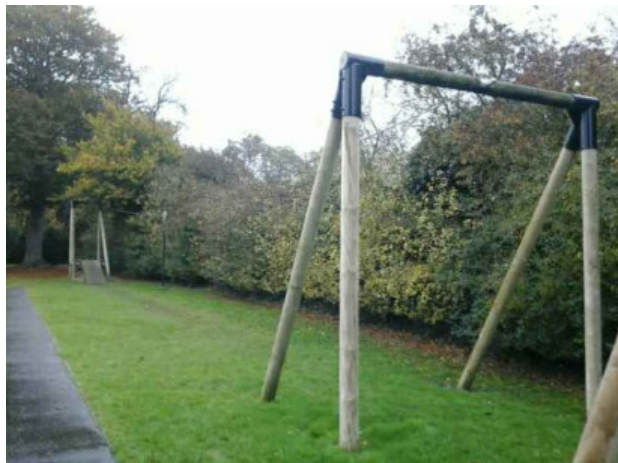
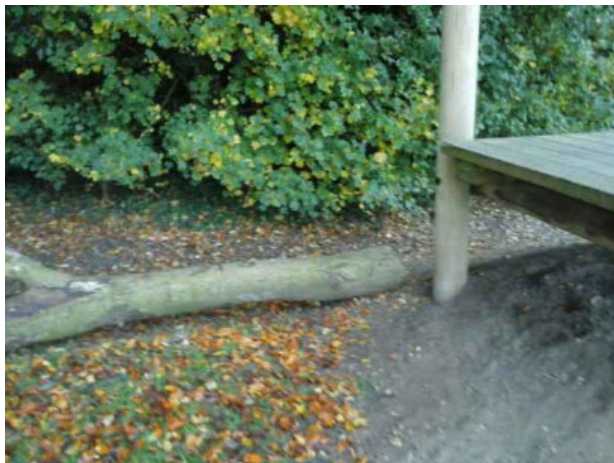
Finding: A tree is within the falling space of the starting platform

Action: Remove the tree

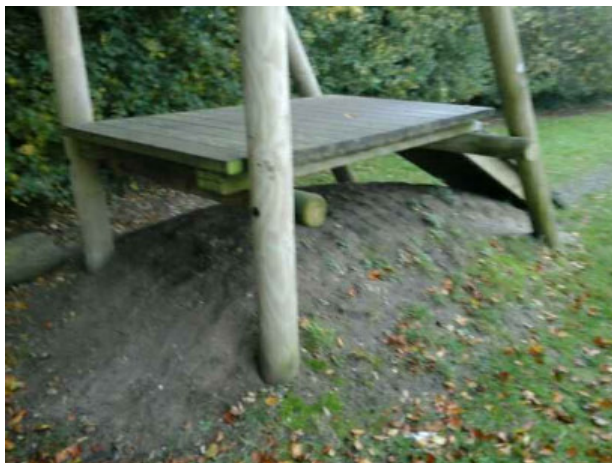
Finding: The surface has eroded in some areas

Action: Reinstate the surface

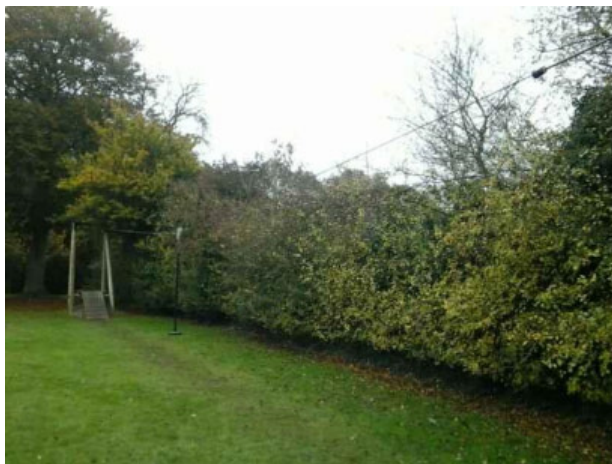
Finding: The height of the seat is less than 400mm when partially loaded

Action: Ensure the seat is a minimum of 400mm above ground level when loaded with 130kg

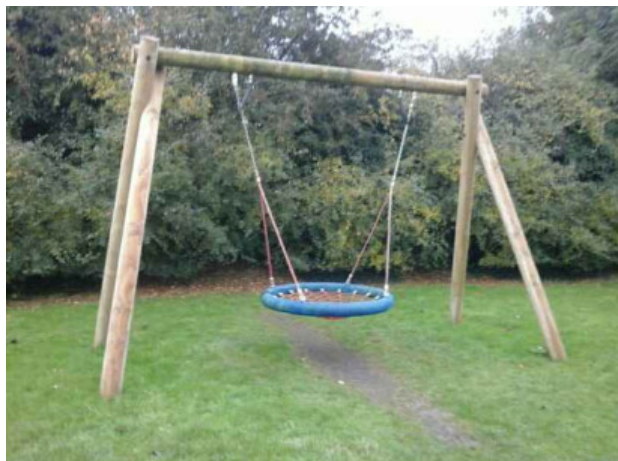
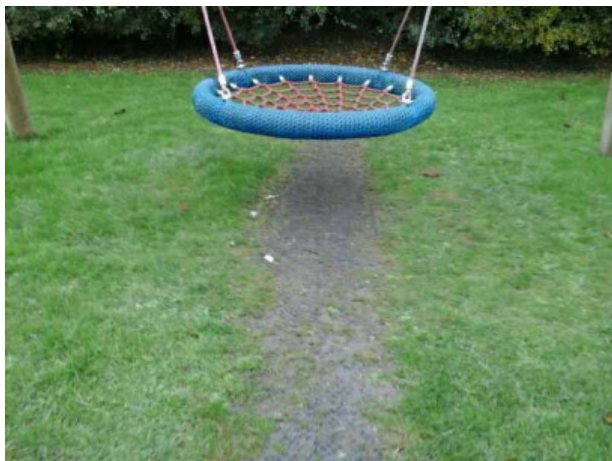
Finding: The grass mats are silted up and the soil is compacted; this may have an effect on the impact absorbing properties of the surface

Action: Lift and relay mats or test impact absorbing properties to ensure the correct surface qualities are maintained for the equipment

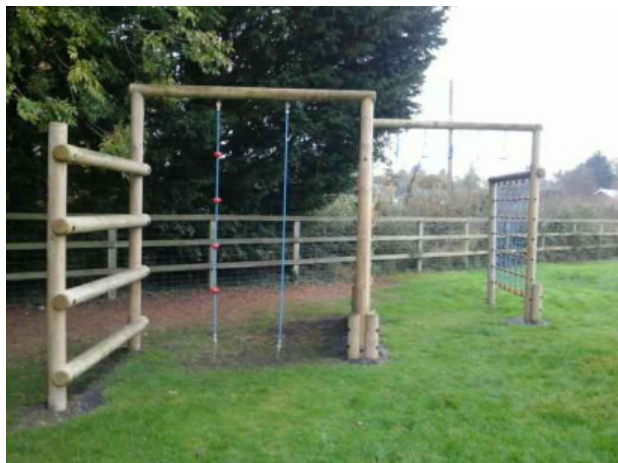
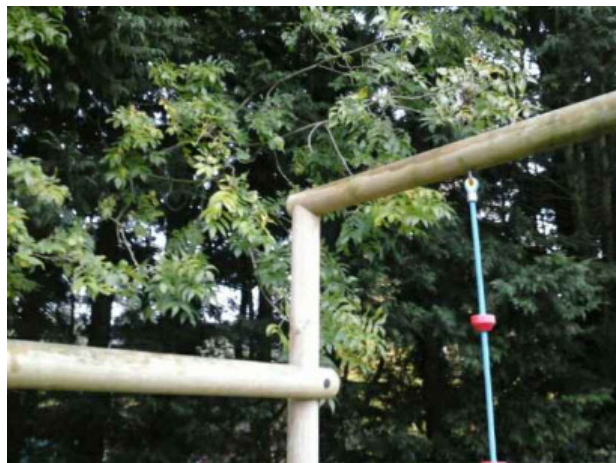
Finding: The tree canopy overhangs the equipment and is less than 2.0m away

Action: Lift tree canopy to ensure a minimum clearance of 2.0m from the equipment
